# The Conservation Message of the Rehabilitated Facilities of the International Institute of Tropical Forestry

Ariel E. Lugo and Jeannette Rullán<sup>1</sup>

Keywords: Sustainable operations, historic building, research facilities, green infrastructure, tropical architecture.

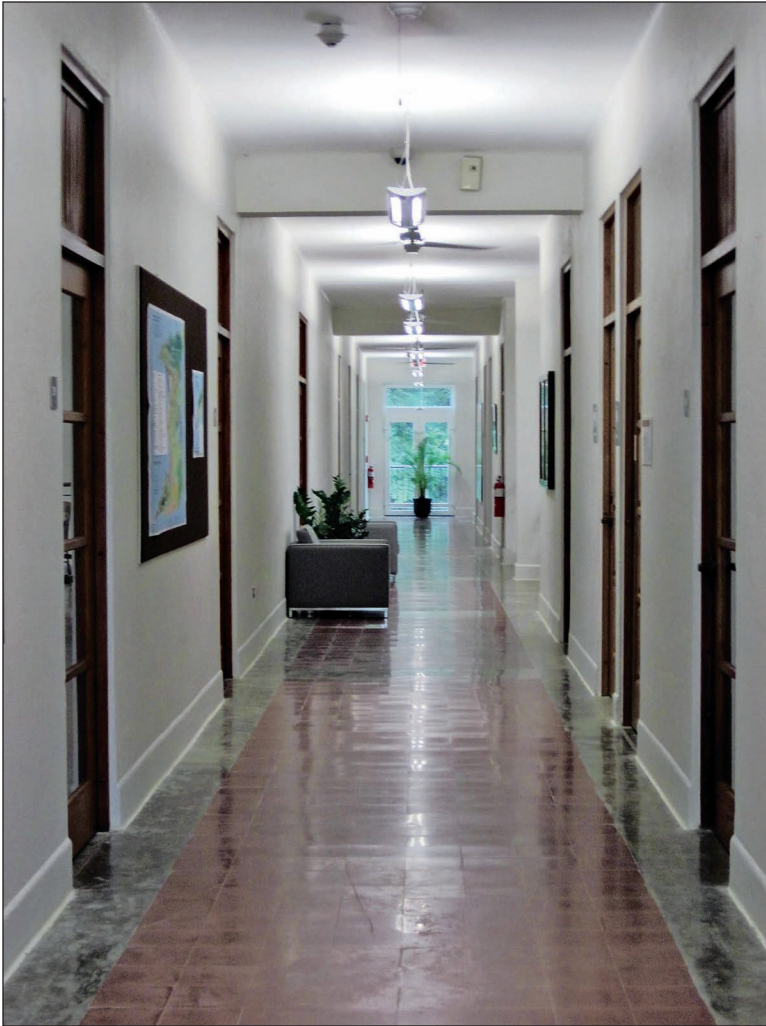
Figure 5—View of the second-floor corridor of the Institute Building with lighting certified to meet Leadership in Energy and Environmental Design standards.

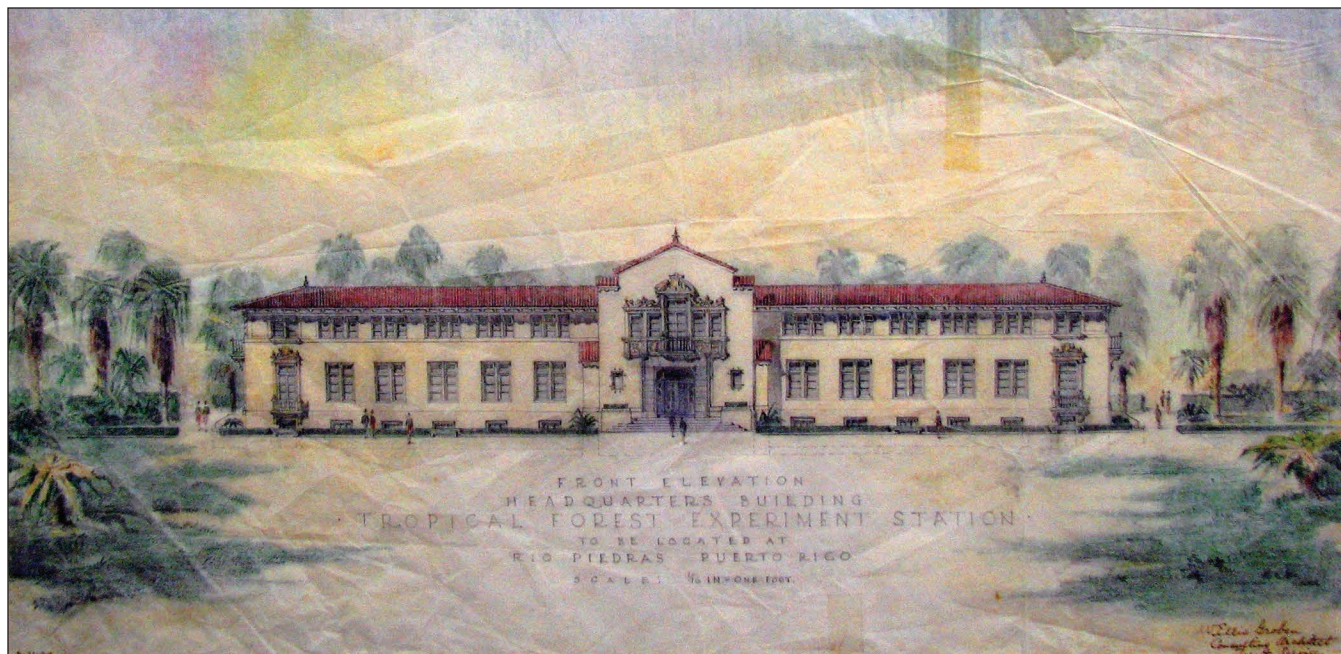
Figure 7—Drawing of the building façade signed by W. Ellis Groben in 1939. The original drawing is in display at the International Institute of Tropical Forestry.

William Ellis (W. Ellis) Groben, a Forest Service architect, designed the Institute Building in 1939 (fig. 7). Construction began in 1941 and was completed in 1942. In the tradition of other notable Forest Service professionals, Groben influenced the agency's approach to building design with what was known as the "Groben Dictates." In 1940, he distributed within the agency a report entitled *Architectural Trend of Future Forest Service Buildings*. In that report, he made the point that architectural designs in the agency should "...represent the traditions, ideals, and purposes of the Forest Service (Groben 1940:17)."

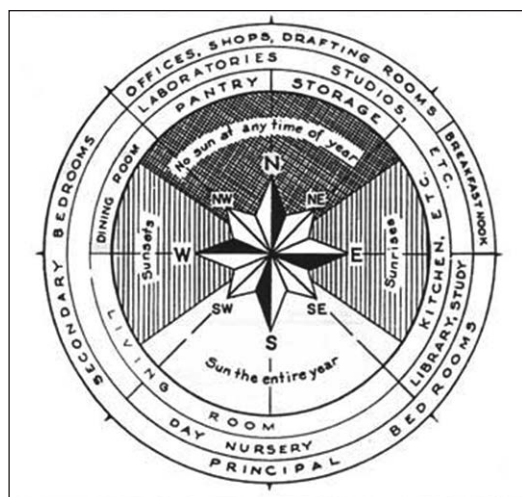
Figure 8—W. Ellis Groben's diagram on building orientation (Grosvenor 1999).

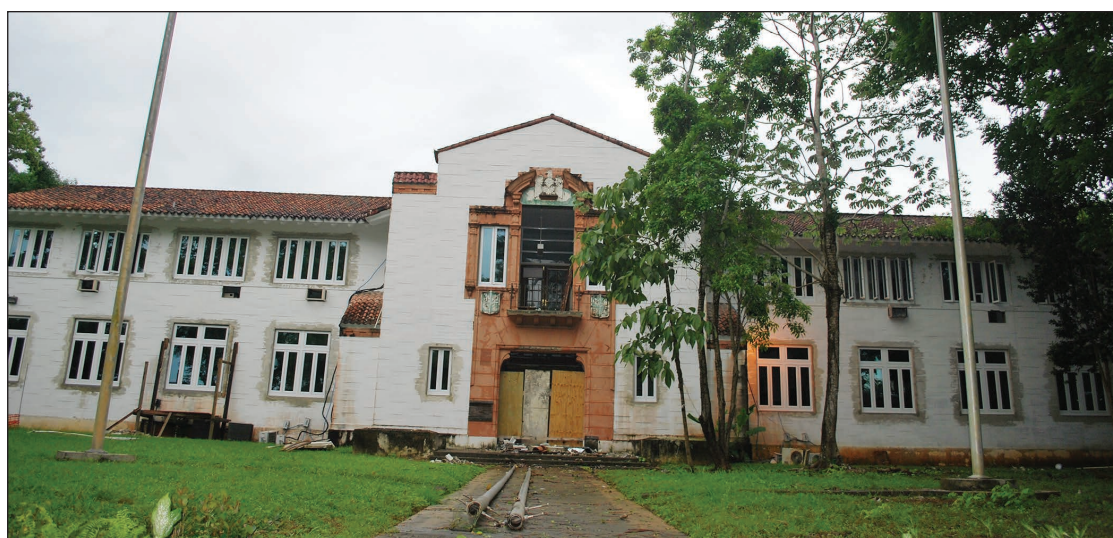
Figure 10—The eastern main entrance door of the Institute building was closed to all foot traffic for many years. In this 2012 photo, the old flagpoles that initiated the discussion about building restoration lay on the ground and the new poles have been erected.

Notably, until 2002, we had no comprehensive plans for rehabilitating the Institute Building. Although the notion of improving access to the Institute Building and expanding building facilities in Río Piedras had been included in the 1991 integrated facilities master plan of the Southern Region, the idea of rehabilitating the building was one that developed slowly and serendipitously. For example, in the 1990s some of the roof tiles of the Institute Building fell off the western façade right in front of the main door of the building. This forced us to close access to the building through that door, and until 2012, no one used that door (fig. 10). All foot traffic to the building was through the eastern door facing the parking lot.

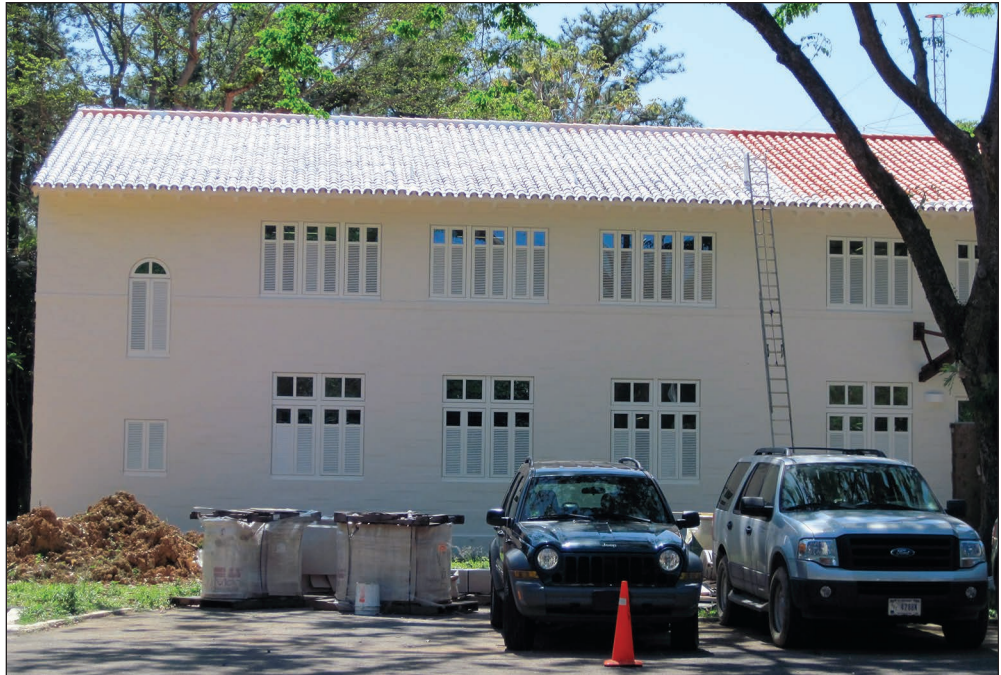
Figure 11—Restoration of the roof tiles of the Institute building. Notice also the new windows.

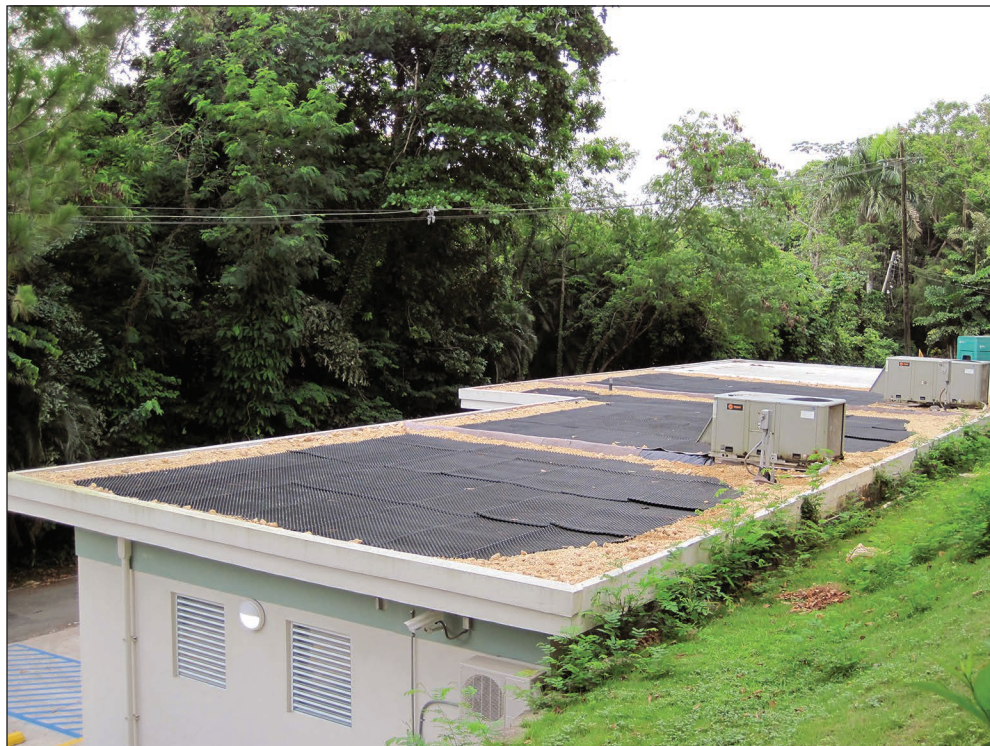
Figure 13—Preparation of the green roof of the Geographic Information System and Remote Sensing Laboratory for planting of green vegetative material.

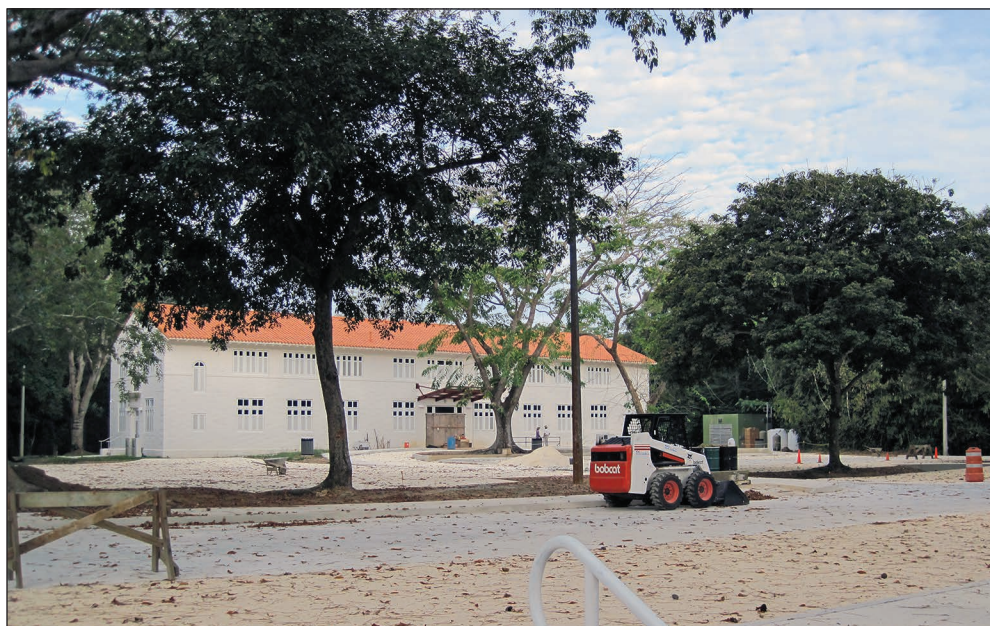
Figure 14—Groundwork in progress at the green parking lot.

The components of the Green Parking Lot system (see fig. 9) include green areas for parking, two vegetated swales, concrete sidewalks and traffic lanes, open water canals, four detention ponds (fig. 21), and a gravel dissipater bed (fig. 22). This bed is located in the outlet of the system above the last vegetated slope, and helps reduce erosion and allows infiltration of any excess rainwater. Concrete surfaces of traffic lanes and sidewalks of the parking lot produce runoff and are more reflective of light than the original blacktop, thus reducing the heat island effect. The green

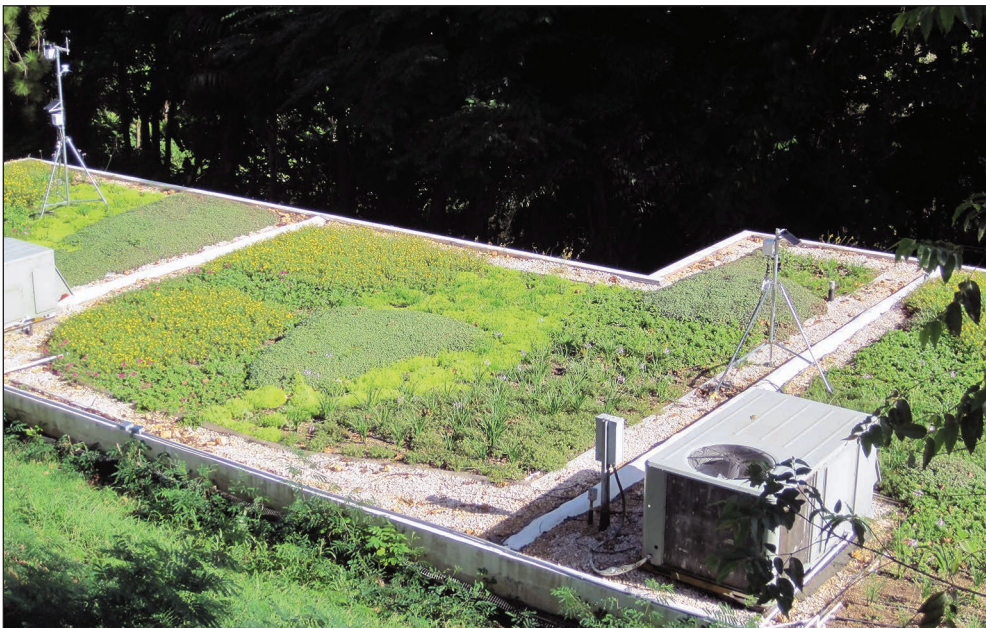
Figure 18—Green roofs of the Geographic Information System and Remote Sensing Laboratory.

Green roofs covering 12,600 ft<sup>2</sup> (1,171 m<sup>2</sup>) were installed in four headquarters buildings: the GIS and Remote Sensing Laboratory, the new addition to the Chemistry Laboratory (fig. 17), the Technology Transfer Conference Center, and the Multipurpose Building (fig. 18). Before construction of green roofs, all buildings in the Institute had cool roofs with the exception of the old chemistry laboratory and Institute Building. Thus, green roofs were installed over cool roofs (fig. 19). The roofs of the GIS and Remote Sensing and Chemistry Laboratories were subdivided into seven separate green roof sections and one cool roof section. For cool roofs, a white ethylene propylene diene monomer (EPDM) membrane was used to insulate the roof and increase reflectivity. On green roofs, black-colored EPDM membranes were installed over the cool roofs. These membranes have a 90 mil thickness (2.29 mm). Green Roofs were designed and maintained following the standards set by the National Roofing Contractor Association, American Standard Testing Materials (green roofs for healthy cities), and the German FLL-guidelines for planning, execution, and upkeep of green roof sites. The project included a moisture retention/protective layer over the cool roof, a drainage system, a filter sheet, growing medium and plant materials, a rainwater harvesting system, monitoring, and maintenance.

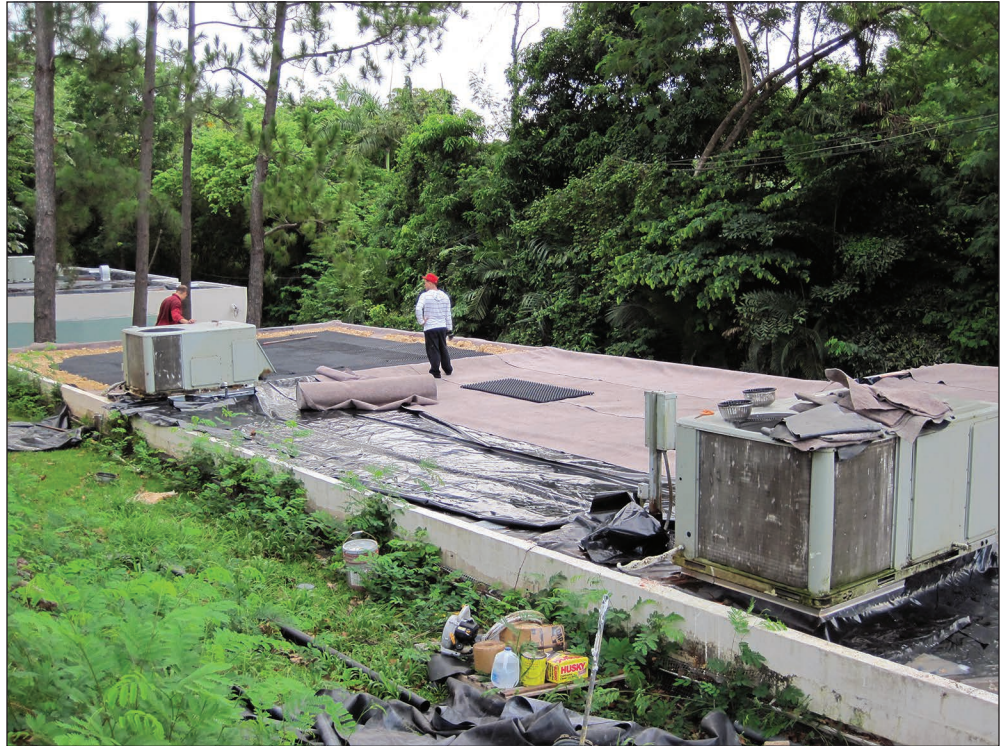
Figure 19—Layering of materials over cool roofs in preparation for the green roof of the Geographic Information System and Remote Sensing Laboratory.

The moisture retention/protective layer protected the waterproofing of the roof. The layer consisted of material made of recycled non-rotting fibers for water- and nutrient-retention as well as providing protection. This layer was 0.2 in (5 mm) thick, weighed 0.1 lb/in<sup>2</sup> (470 g/m<sup>2</sup>), had a water-retention capacity of about 0.12 gal/ft<sup>2</sup> (5 L/m<sup>2</sup>), and was bitumen-resistant and biologically and chemically neutral. The drainage system provided adequate drainage and water retention to ensure plant survivability. The material of this system was made of recycled polyethylene, with water-retaining troughs and openings for ventilation and evaporation. The drainage system also contained a drainage canal system on the underside. The system is bitumen-resistant and resists compression to more than 24.7 lb/in<sup>2</sup> or 170 kN/m<sup>2</sup> (1.73 kg/cm<sup>2</sup>). The water-retention capacity is approximately 0.1 gal/ft<sup>2</sup> (4 L/m<sup>2</sup>), height is about 1.6 in (40 mm), and weight is about 0.5 lb/ft<sup>2</sup> (2.2 kg/m<sup>2</sup>).

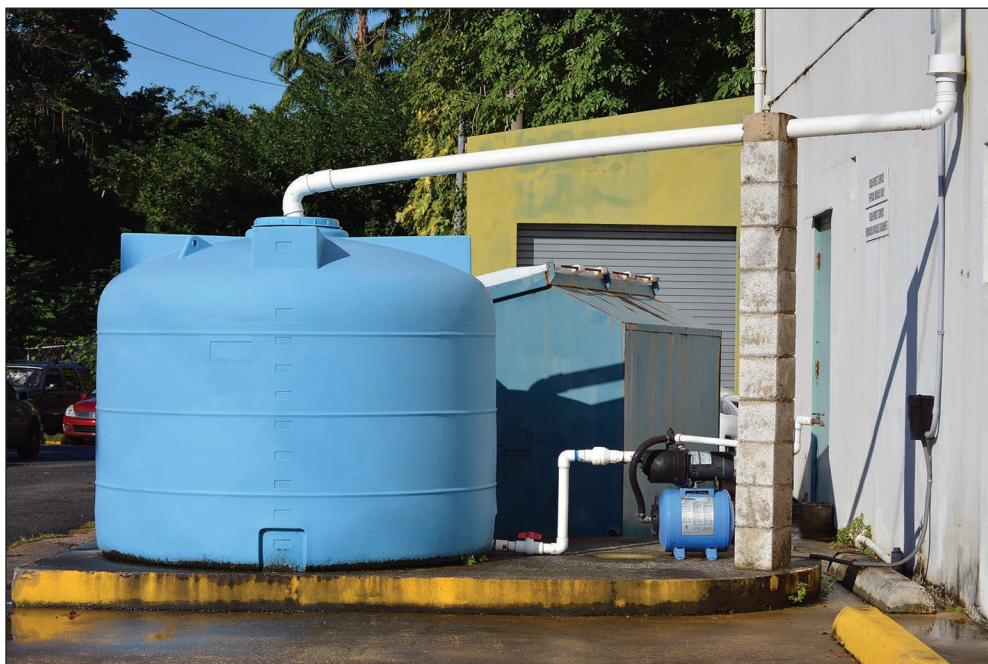
Figure 20—The roof rainwater collecting system in back of the Frank H. Wadsworth Library. Shown are the drainage pipes from the roof to the blue cistern, pump used to return water to the roof during draught conditions, and blue cistern where water is stored.

The rainwater harvesting system consisted of a drainage system, pumps, and cisterns (fig. 20). The drainage conveys all roof rainwater to two 2,400-gallon or two 1,000-gallon (9,085 or 3,785 L, respectively) cisterns (size depends on the roof area drained) located on the side of buildings. The total water storage capacity of the four cisterns is 6,800 gallons. When full, the overflow of the cisterns flows into surrounding green strips. Cisterns are outfitted so that water can be used for gardening and all-purpose cleaning at the Institute. Also, a  $\frac{3}{4}$ -hp electrical pump can return water from the cisterns to the roof when a humidity sensor in the soil indicates a water shortage for plants growing on the green roof. Maintenance involves weeding, upkeep of equipment, and overall roof functioning. The monitoring system is described below.

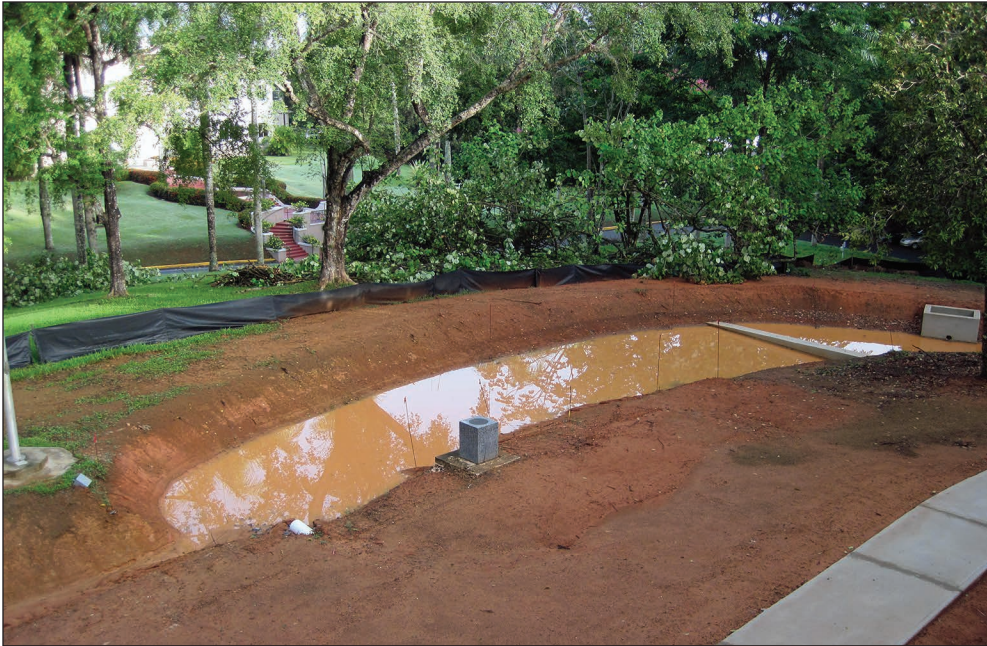
Figure 21—Construction of the concrete sidewalks, open water canals, and detention pond in front of the Institute Building. The system outlet is the concrete box on the far right. The muddiness of the water is due to construction work. The marble cube in the center is a calibrated monument for the Geographic Position System Coordinates of this location. The official name for this cube is 100 Year Commemorative Monument and High Accuracy Geodetic Control Mark.

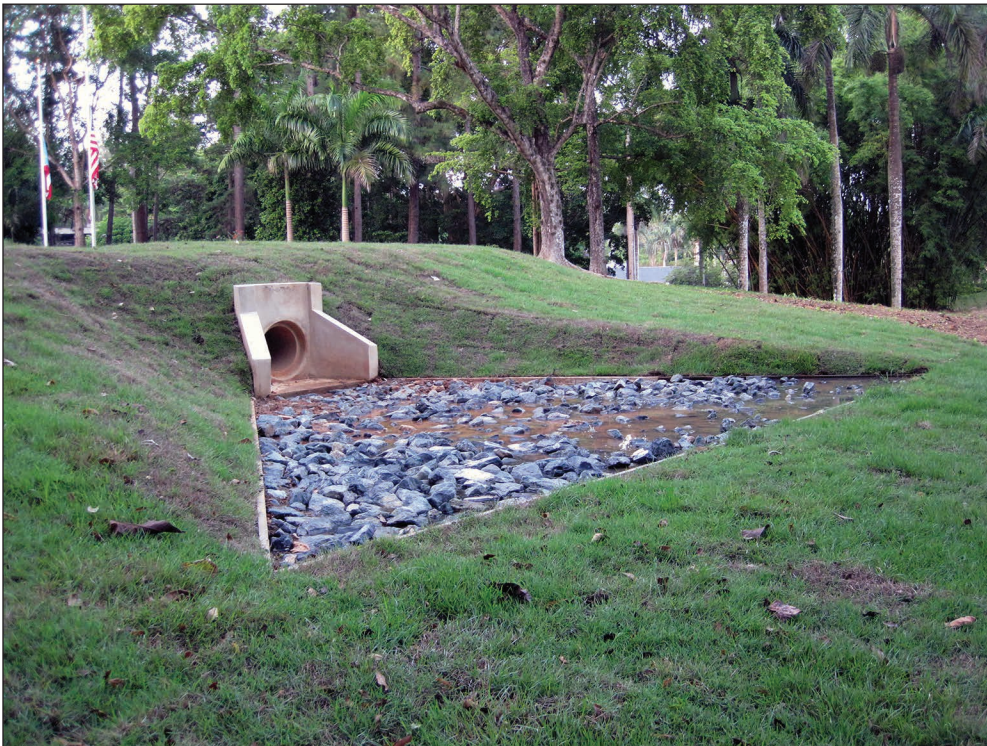
Figure 22—Outlet for the hydrologic system of the Green Parking Lot. Rocks dissipate the energy of outflowing waters before they flow downslope through the lawn, which acts as a green swale that absorbs and evaporates water.

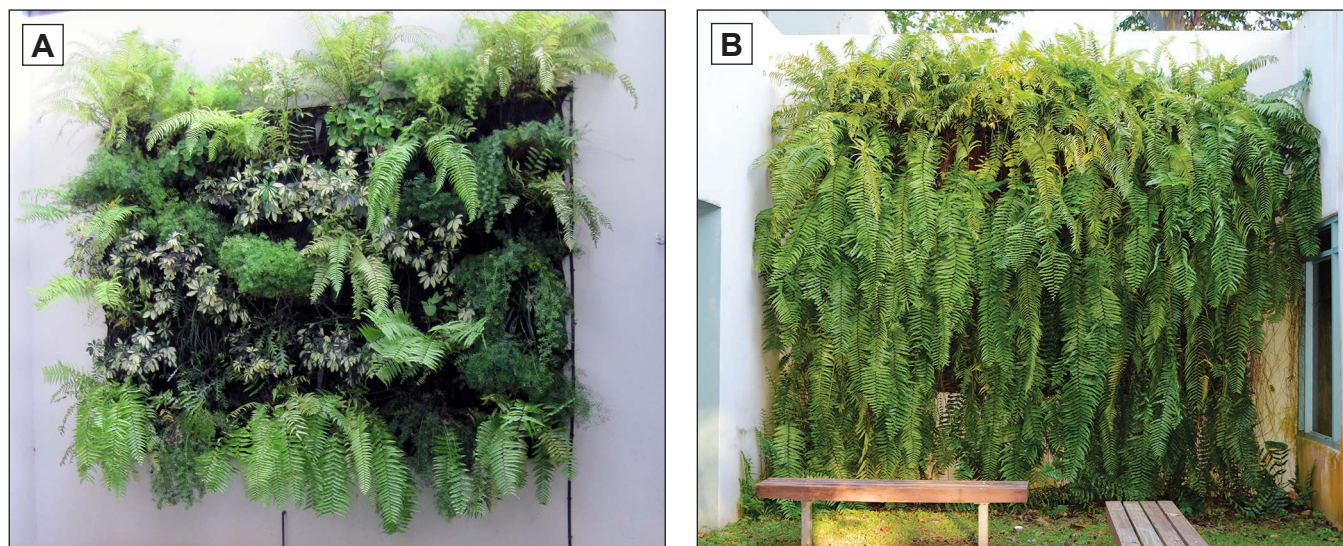
Figure 23—The green wall between the Chemistry Laboratory and the Technology Transfer Conference Center was installed on July 2011. Contrast (a) the initial planting with (b) current state of this wall (b).

On July 5, 2011 Mary Jeane Sánchez, head of the Institute's Chemistry Laboratory, proposed the construction of a green wall between the Chemistry Laboratory and the Technology Transfer Conference Center (fig. 23). The wall was designed and installed by Flower Box of Puerto Rico in August 2011. The system consists of a substrate constructed of recycled materials and an automatic watering system. The initial objective was to spell the Institute initials (IITF) with plants (bromeliads and ferns), but this objective was discarded owing to the anticipated high maintenance

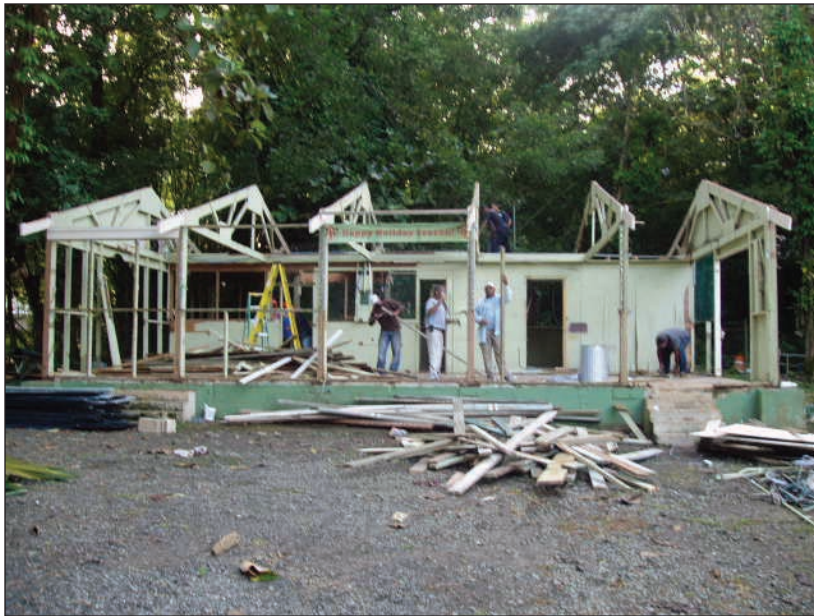
Figure 24—Woodshop building in the Sabana Field Research Station during the demolition and recycling process.

The rehabilitation of the Institute Building used 98 percent of all structural elements and 78 percent of the non-structural elements of the building. However, the 22 percent of the internal elements removed was donated, reused, or recycled in such a way as to minimize the involvement of Institute personnel. Thus, the recycling strategy used both at the Río Piedras and Sabana construction sites lowered demolition and insurance costs as well as hauling and landfill charges (fig. 24). To our knowledge, this is the first time the initiative to donate materials as a method to reduce waste hauled and disposed in the landfill was executed. Nevertheless, it proved to be economically beneficial to both the agency and the benefiting entities.

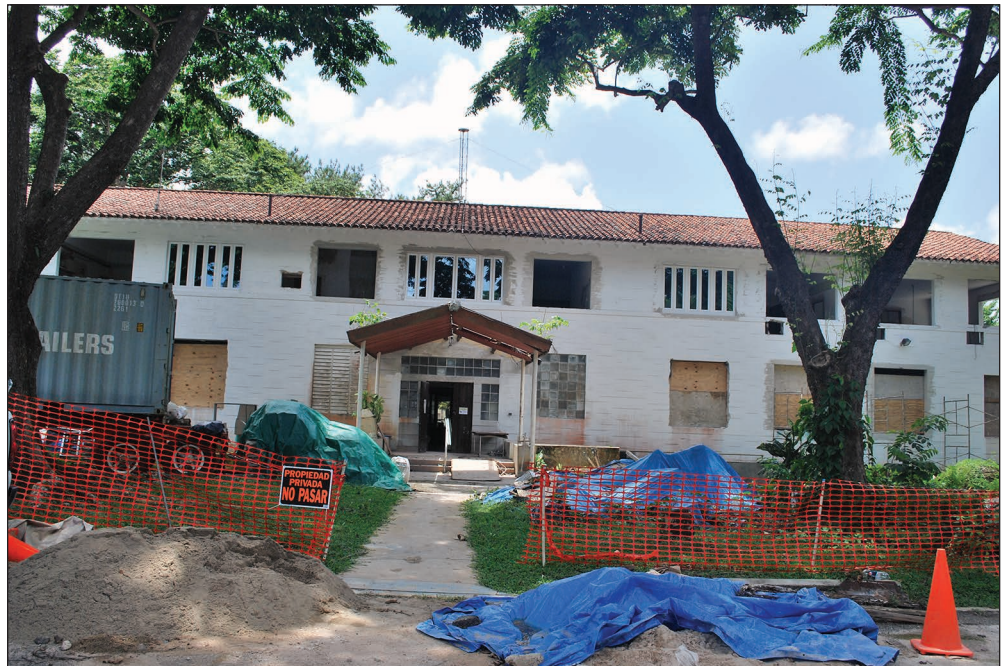
Figure 26—Construction in progress at the Institute building.

Construction of all facilities took almost 6 years. A significant delay was caused by many factors, among them funding, contracting, contractor's performance, and procurement of windows (fig. 26).

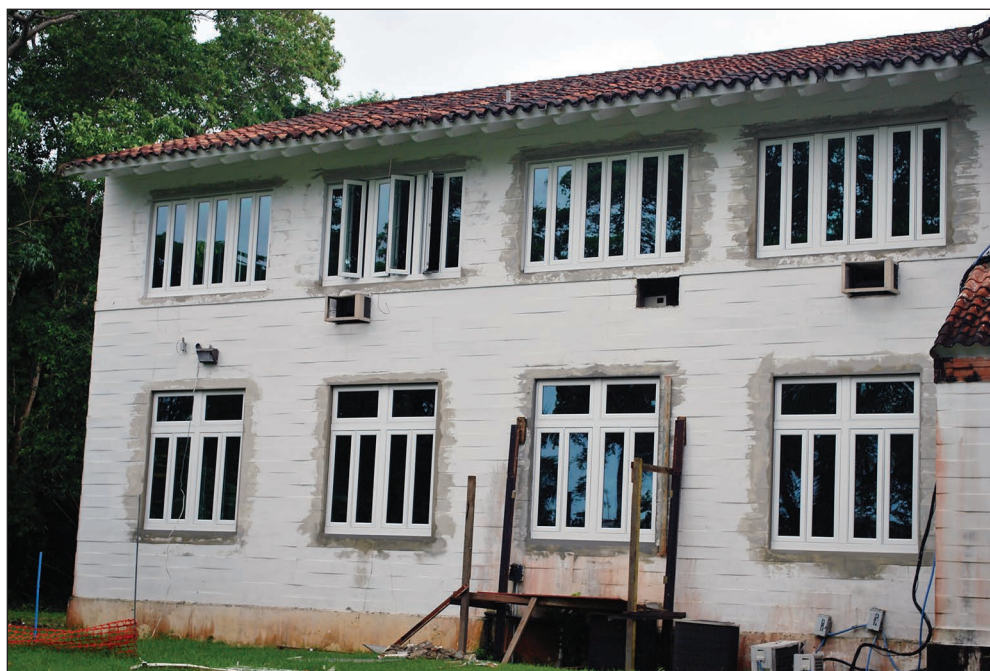
Figure 27—Installation of new windows at the Institute building.

to find parts that could be assembled to achieve the required proportions. Storm King Windows & Doors Inc. did not have the capacity to draft shop drawings, so RMA Architects provided the necessary support. This was a long journey of trial-and-error until the final design was achieved. Storm King Windows & Doors Inc., using reinforced PVC with aluminum жалюзиs to simulate the original window design, built exterior windows and doors in Ciales, Puerto Rico. The windows are NFRC-certified and highly energy efficient (fig. 27). The frames are metal-covered with PVC and they reduce the transfer of heat from the outside through the frame. The windows have a double glass pane, with the space between the glasses filled with argon gas, which further reduces heat transfer through the windowpanes.

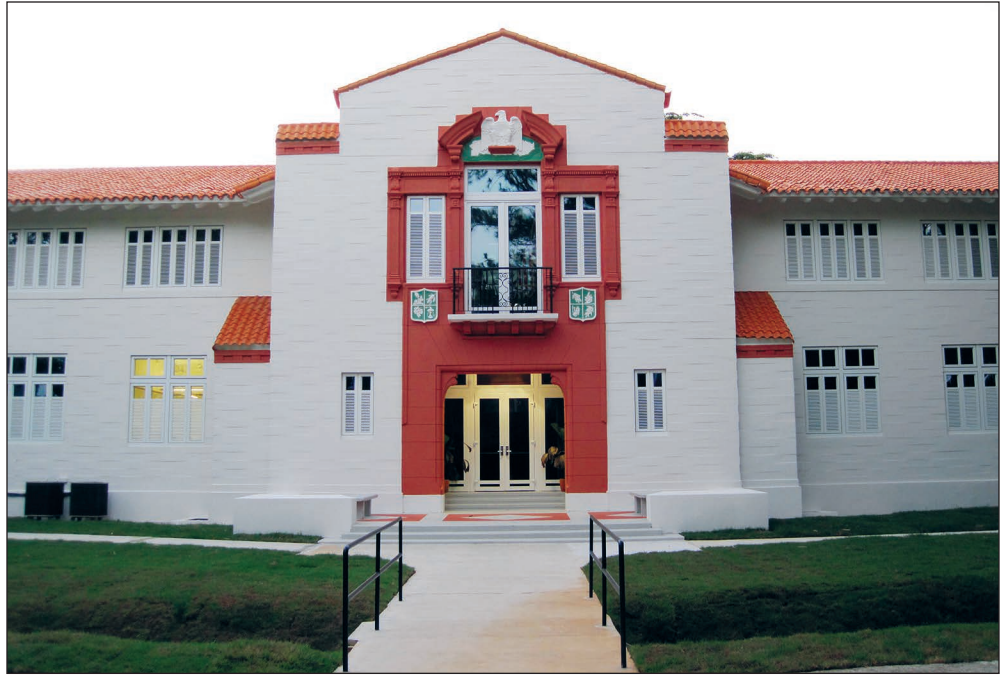
Figure 30—Completed main façade of the Institute building. The hand rails mark that passage of the drainage canals that originate in the Green Parking Lot.

The Institute Building was redesigned for employee comfort, health, safety, and accessibility (fig. 30). Key objective of the rehabilitation were to recover the historic finishes and space design and to limit the use of new materials. The building interior is designed to assure that employees have sufficient space for accomplishing their tasks, and it also provides for public spaces as well as employee lounges. A room is dedicated to the Institute's research files, and the basement, used earlier as a print shop, office space (Ariel Lugo had his office there in 1963), and meeting room is now used for multiple purposes, as needed. All walls and false ceilings were stripped to change roof height from 8 ft to 13 ft (2.44 to 3.96 m), and the original concrete surfaces of the building were exposed. Existing walls were furred with insulation and gypsum board to conceal electrical and communications infrastructure and to insulate walls from outside heat or adjacent spaces. The gypsum board also resists mold, and provides a healthy environment for employees and visitors. The original stairs on the north side of the building had been covered to extend the use of office space. During the rehabilitation, the area was uncovered, the stairs demolished, and windows and new stairs constructed to comply with construction codes that stipulate a means of egress. An energy-efficient elevator was incorporated into the original structure to connect all three floors in compliance with accessibility requirements. During construction, a portal originally intended as a reception area was discovered in the first floor, which led us to relocate the receptionist to that space. Building infrastructure is organized above the hallways and suspended from the ceiling, from where it is distributed to individual office spaces.

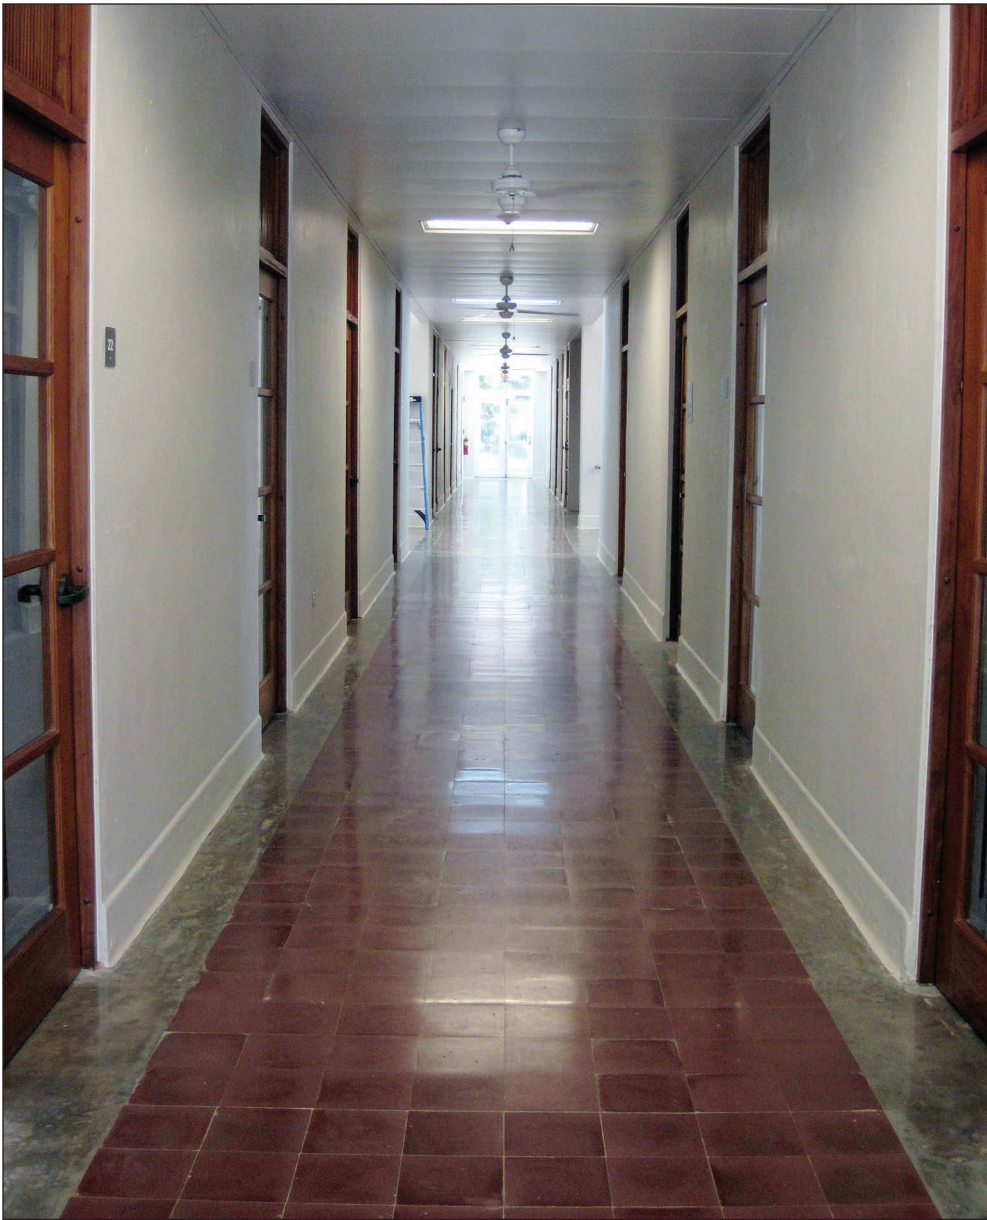
Figure 31—Natural light entering the Institute building through exterior doors.

The light environment was carefully planned. Natural light enters the building through windows and exterior doors (fig. 31). Office doors have glass panels to allow natural light to illuminate hallways. All light fixtures are energy efficient and are programmable for an output consistent with the light intensity needed for employees to work safely. Most lights are turned on or off by motion detectors. To avoid light pollution, the location and height of interior light fixtures was planned to prevent light from exiting through the windows to the outdoors.

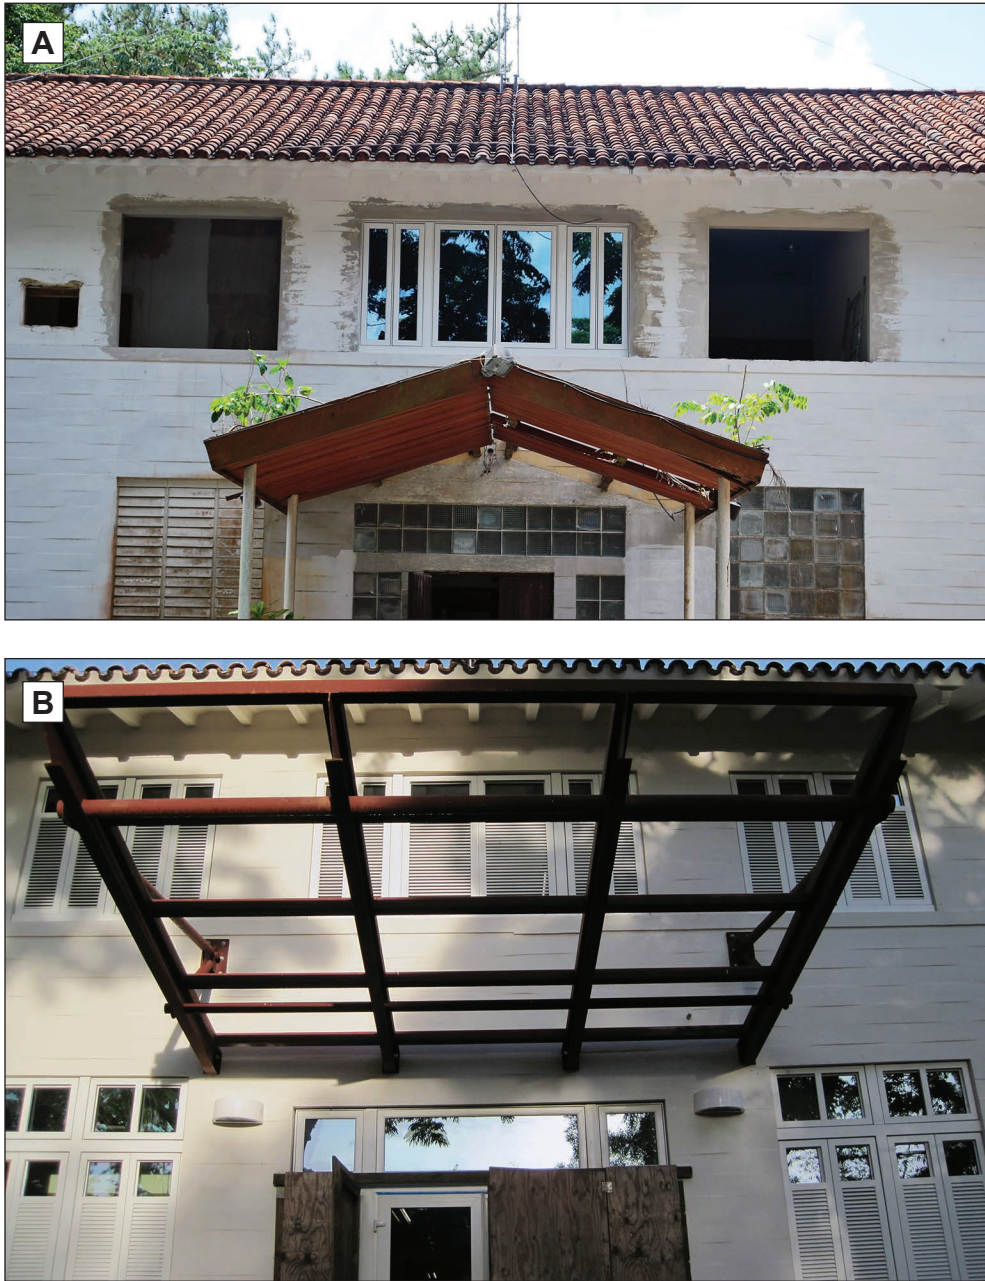
Figure 32—The Institute building had an entrance portal on the west end facing the parking lot (a), which was not part of the original building design. We retained the function of this portal with the installation of a new structure (b), which has not been painted as designed, owing to budget limitations.

entrance. We elected to retain this feature but had to design it in a way that would be obvious to users that this was an add-on. This action follows the restoration guidelines suggested by architect Camillo Boito, who focused attention on the restoration of ancient buildings. Some users of the Institute Building criticize this feature of the rehabilitation because they object to the aesthetics of the structure (fig. 32b).

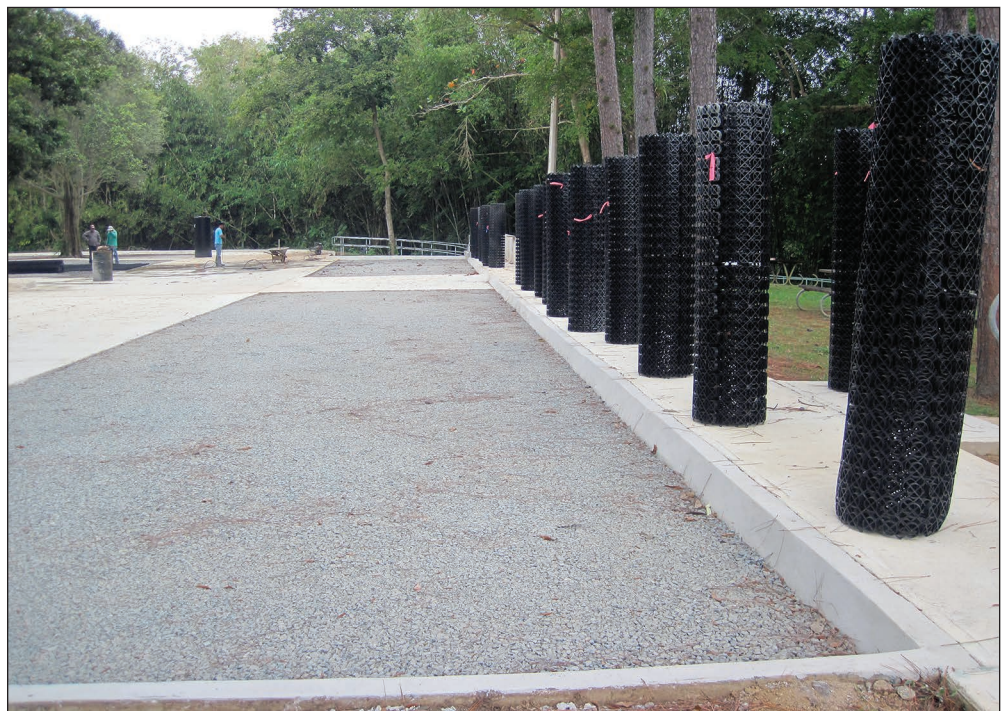
Figure 33—The Green Parking Lot has several layers of materials. Black plastic rings seen on the sidewalk were added to these layers to provide strength to the system.

In time, maintenance of the Green Parking Lot could not maintain the grass green because of several factors including shading, slow growth, and heavy rains that eroded and washed out the upper surface of the parking lot, exposing the plastic cylinders in many places. The system continued to function hydrologically but it was no longer green.

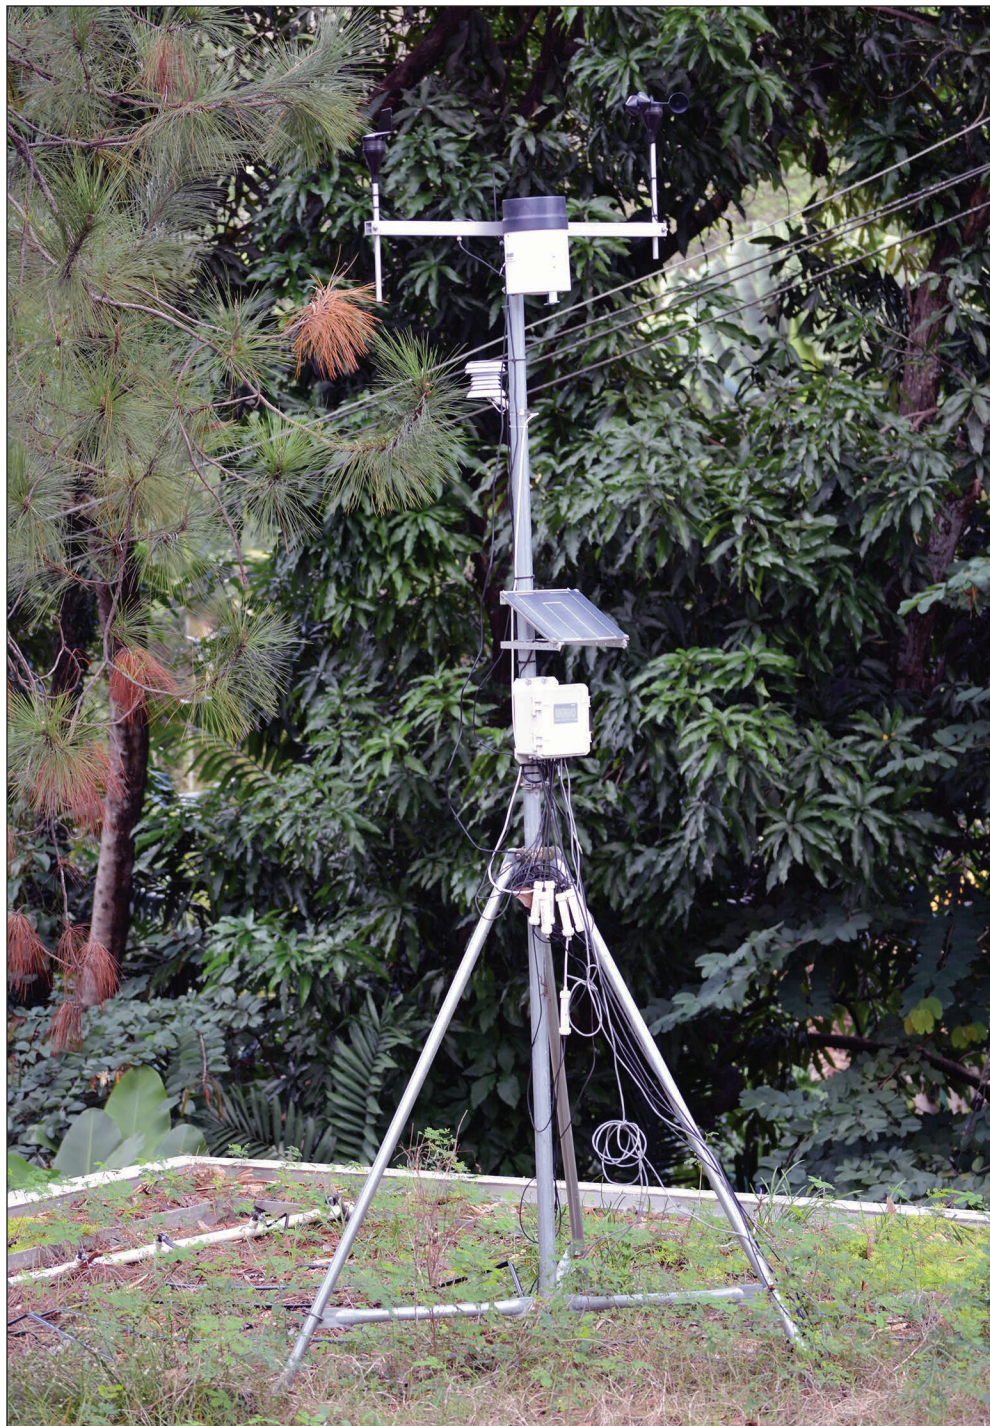
Figure 38—One of two Campbell weather stations on the green roofs. These stations monitor air temperature and humidity, wind speed, energy incidence, and rainfall.

The monitoring program design included 2 precipitation gages; 13 temperature probes; 7 humidity sensors, 1 each for wind speed and direction; 3 radiometers; and 1 heat flux sensor. All these sensors and the weather stations (80 sensors in total) are connected to the two Campbell data logger programmed to read each sensor. Data are transmitted to the Campbell Company website, from which it is periodically retrieved and stored in an Institute server. Real-time data can be displayed to the public on a plasma screen.

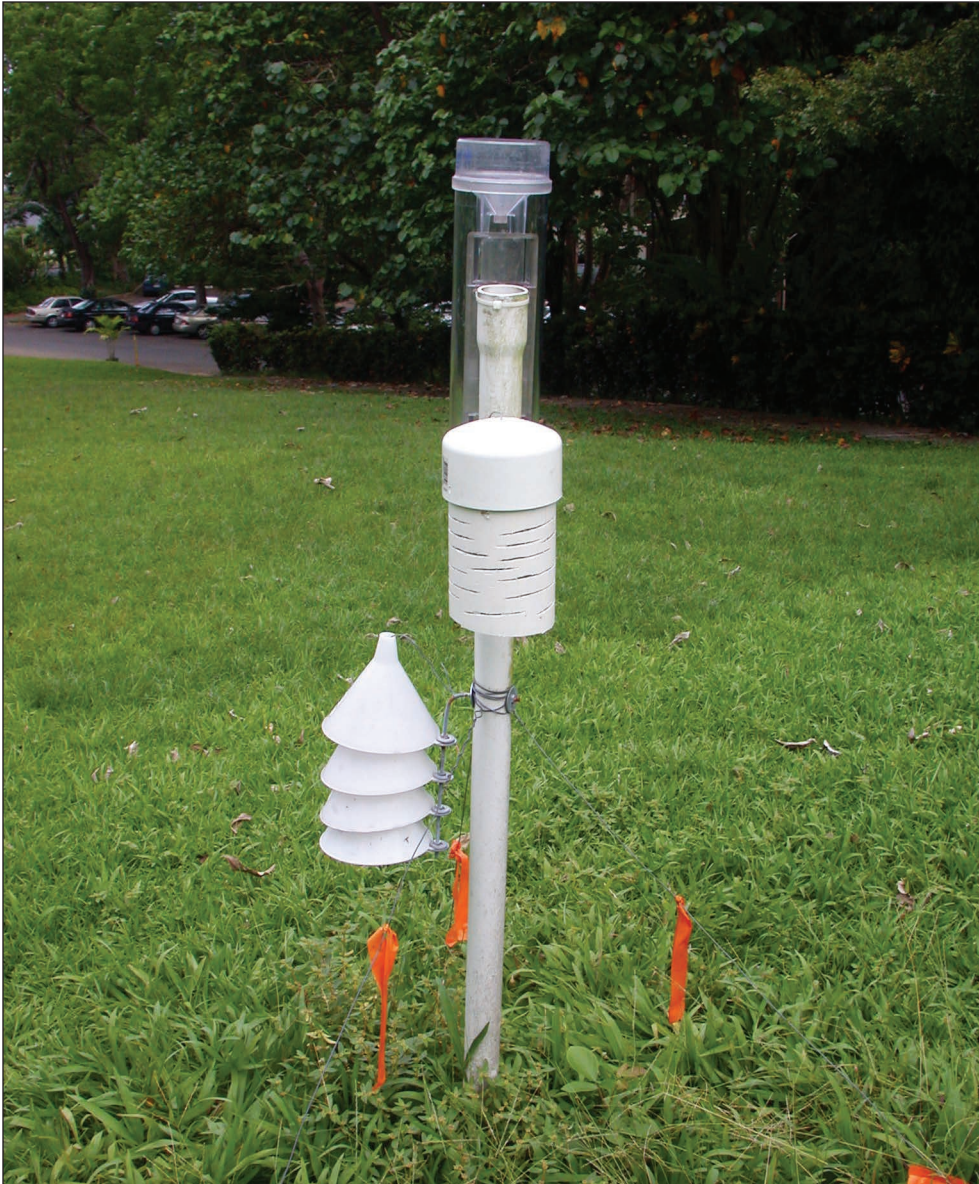
Figure 39—Climatological data sensors (temperature and rainfall) are part of a climate station operated by the Institute in front of the Institute building.

We soon realized that the green parking lot and roofs offered a new research opportunity for the Institute. The tropics lack standards for green roof establishment and operation, including the recommended soil depth and composition, suitable plant species, and evaluation of the effectiveness of the green roof itself. Therefore, we included a monitoring scheme in the roof contract so that we could track its effectiveness in three areas: the balances of energy, water, and nutrients. To accomplish this we located two Campbell Scientific weather stations on the roofs to monitor air temperature and humidity, wind speed, energy incidence, and rainfall (fig. 38). Hydrological and temperature sensors were also placed on the soil surface, inside the soil volume, and on the surface of the roof. These measurements were made on cool and green roofs. A hydrological sensor was also placed on the detention ponds just before the drain to the swale on the front of the Institute Building. The Institute has also operated since 2002 a climate station just below the outflow of the detention ponds (fig. 39).

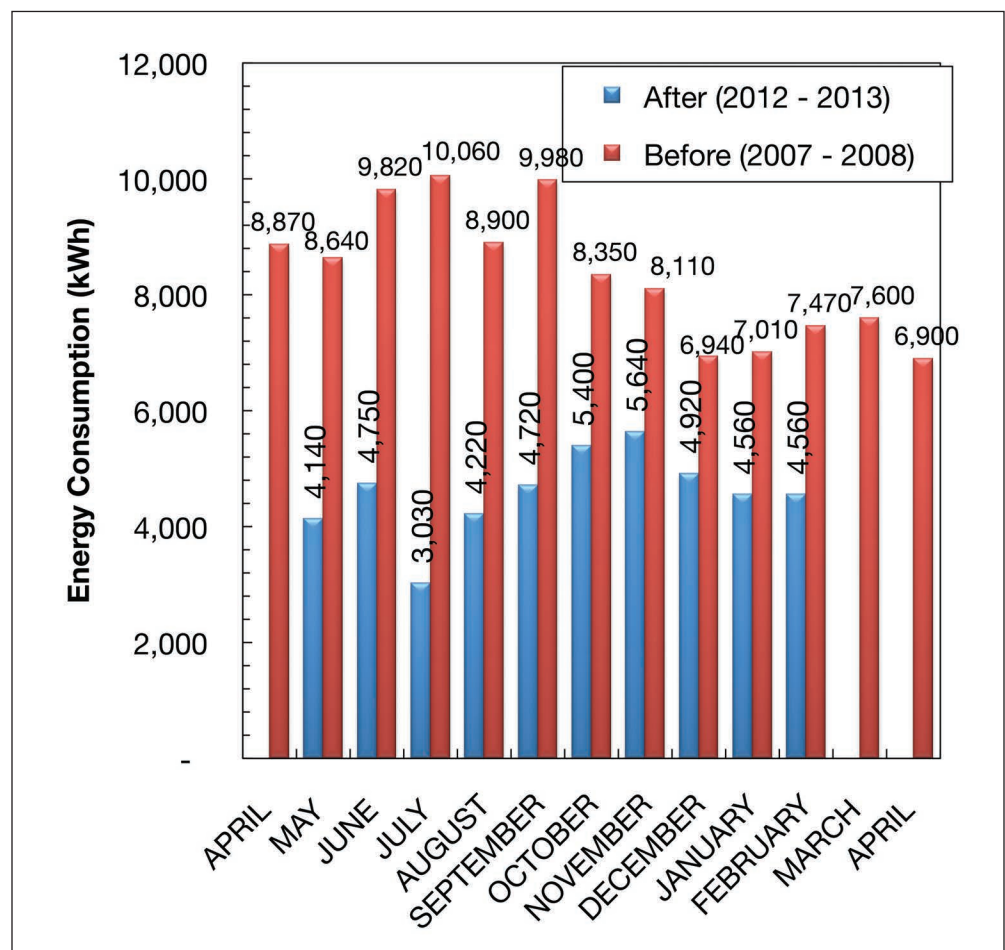
Figure 40—Monthly rate of energy consumption by the Frank H. Wadsworth Library the last year it was operated before restoration and the first year after restoration.
