## **Report on 2004 Field Season**

### **Monitoring the Effectiveness and Validating Response to the Road Related Mitigation Practices Implemented on the Pike's Peak Highway**

**Second Year**

**April 20, 2005**

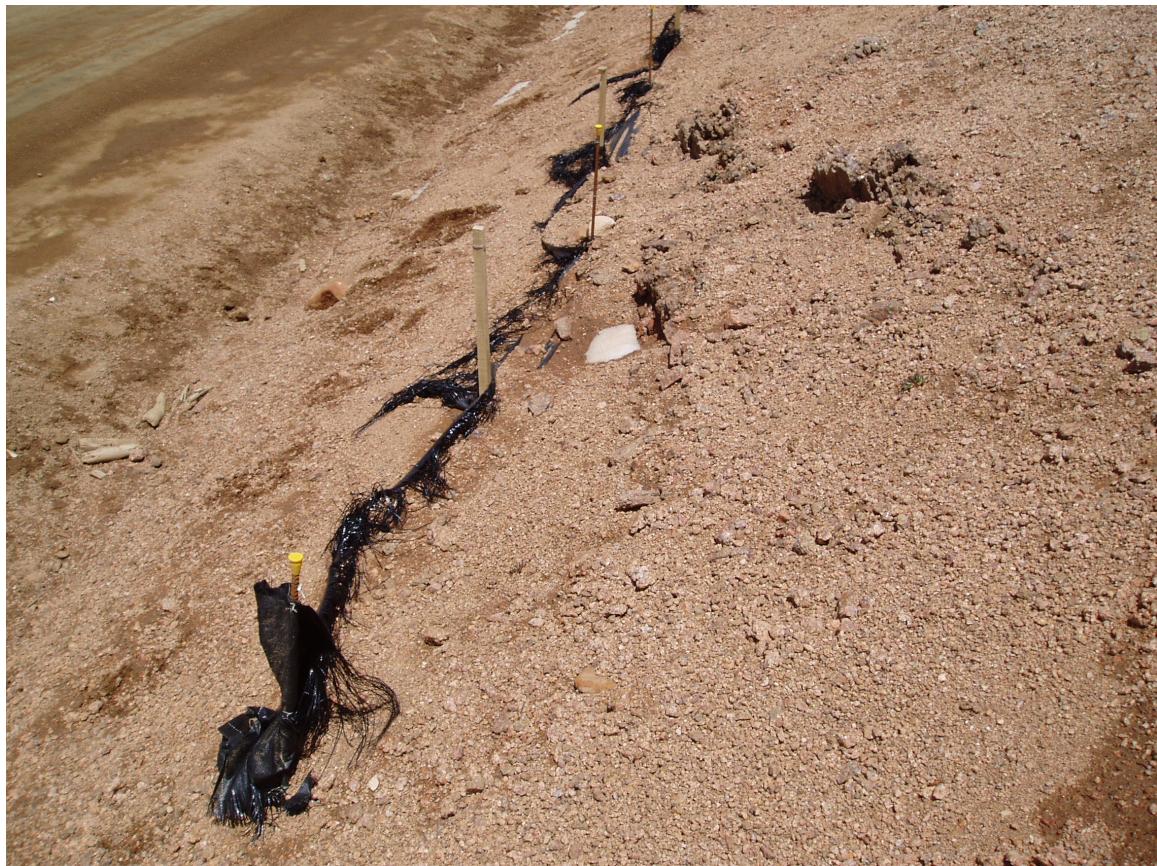
Figure 3. Condition of lower silt fence at site 123CS in spring 2004.

Interestingly enough, the upper silt fence at 123CS remained intact and required only minimal repair.

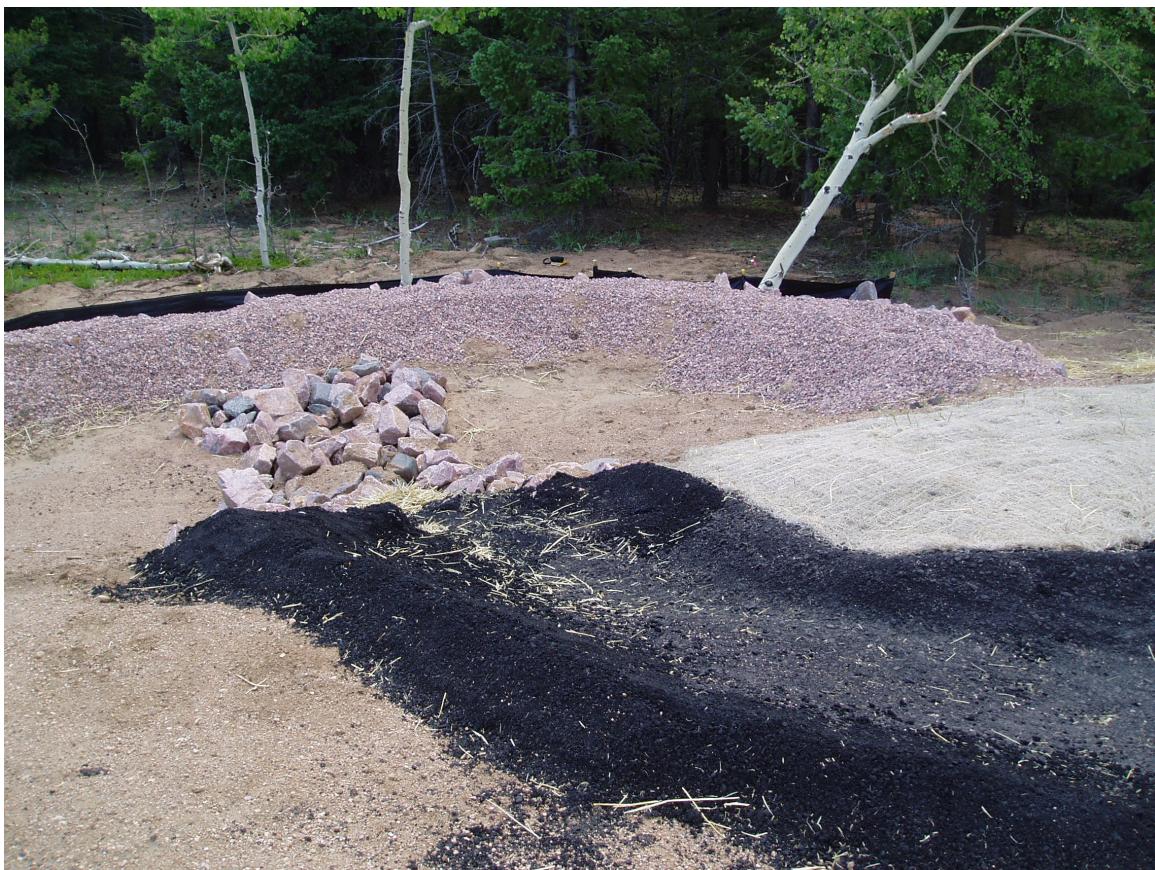
Figure 7. Example of rip-rap velocity dissipator in rock weir 161RW.

In 2004, 17 rock weirs were surveyed to determine their effectiveness in trapping sediment. Volume of sediment captured by each structure is determined by comparing two grid surveys of each basin and calculating fill volume differences from the DTM's. To determine effectiveness in trapping sediment, we installed silt fences below the rock weirs to capture any material that might pass over, under, or through the structure. These fences were surveyed in the same manner as the cut and fill slope silt fences. In 2004, rip-rap was added to several rock weirs at the terminus of the drainage ditches to dissipate energy as storm drainage scoured and piped through (under) the weirs (Figure 7) which altered the discharge location requiring us to extend the silt fences below these weirs. This also changed the void volume of the weirs and for the purpose of calculating sediment accumulation the area in each weir covered by the rip-rap was excluded.

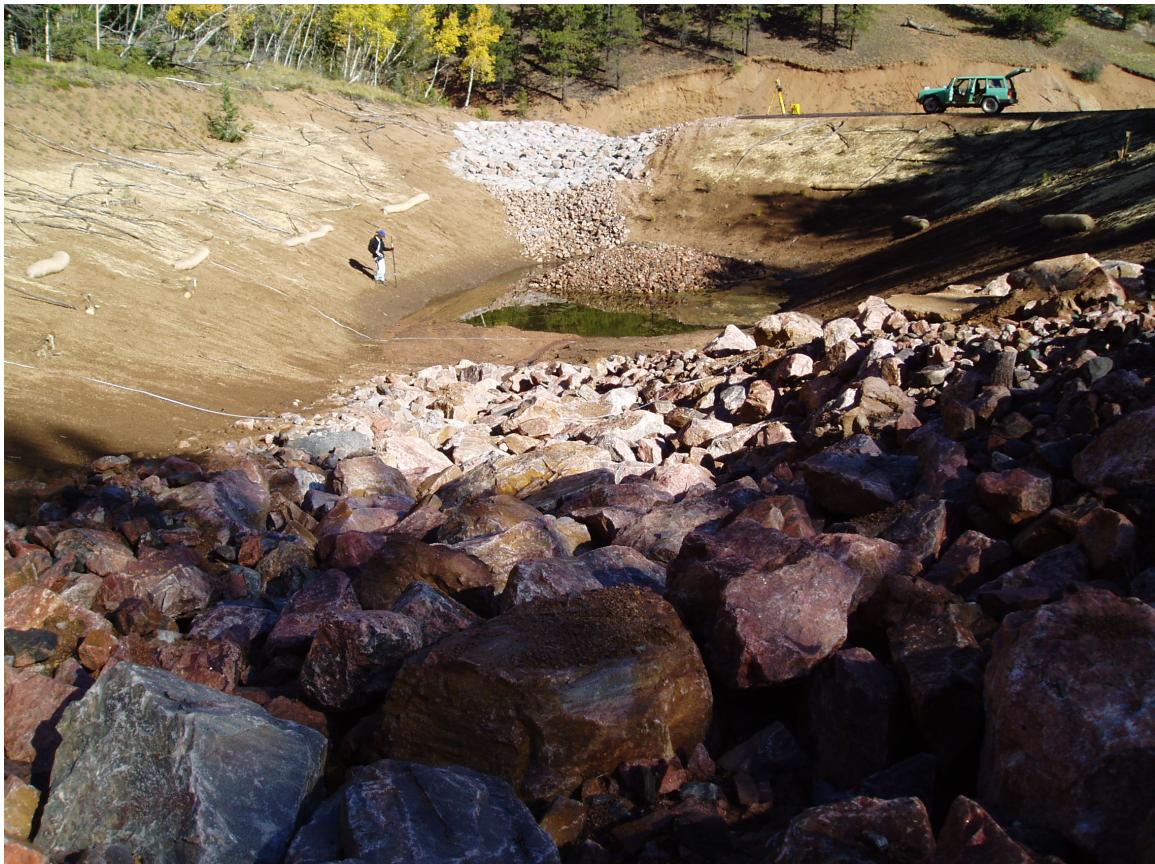
Figure #9. View of sediment pond 199RW from XSA in conveyance channel looking north. Note large rock in channel (forefront), rip-rap from grouted spillway down to the pond, erosion control measures within the basin such as excelsior logs, erosion control fabric, and woody debris.

This was the first year the large sediment pond in Basin 2 (199RW) was in operation. Unlike the rock weirs which drain relatively small sections of road, this pond collects storm drainage from 1.3 miles of highway and in a long network of shotcrete drainage ditches and culverts diverting storm runoff from Crystal Creek (North Fork) into the Ski Creek basin. Water enters the pond, is filtered through a gravel-encased perforated standpipe, and discharged through a culvert downstream. The monitoring effort for the pond includes 5 cross sections to estimate volumetric changes in sediment accumulation, suspended sediment samples taken above the pond where the shotcrete conveyance channel ends and at the outlet (pipe) during storm runoff to measure effectiveness in capturing sediment, and 3 cross sections in the channel below the pond outlet (184CC) to measure changes in channel dimension. Storm intensities this year prompted modifications in the pond design to minimize in-pond erosion such as extending the rip-

rap channel from the end of the shotcrete conveyance channel to the base of the pool, increasing the size of the rip-rap, adding rip-rap to the unprotected area below the grouted spillway, and adding roughness and erosion control blankets to the pond sides (Figure 9). We made three surveys of pond cross sections (Appendix G) but the in-pond erosion and mid-season construction make it impossible to determine the source of the material responsible for the changes in cross sectional area measured in 2004 (Table 11).

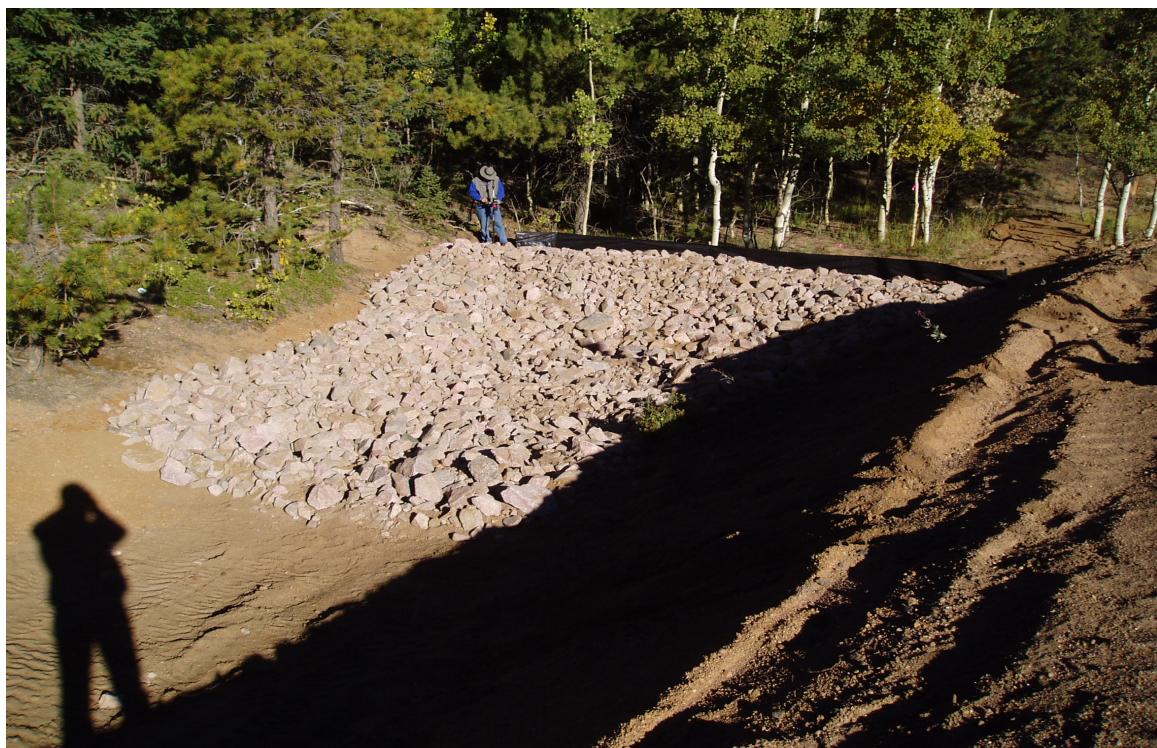
Figure 10. Rock apron site 163RA September 2003.

There are five locations where water is discharged off the road and filtered through riprap without design of a weir or settling pond. Site 163RA is a rock apron in Basin 2 established in September 2003 (Figure 10). We installed a silt fence below the apron in

order to determine its effectiveness in reducing the sediment load but have not yet surveyed for conveyance channel cross sections below the apron to help determine its effectiveness in reducing storm runoff energy.

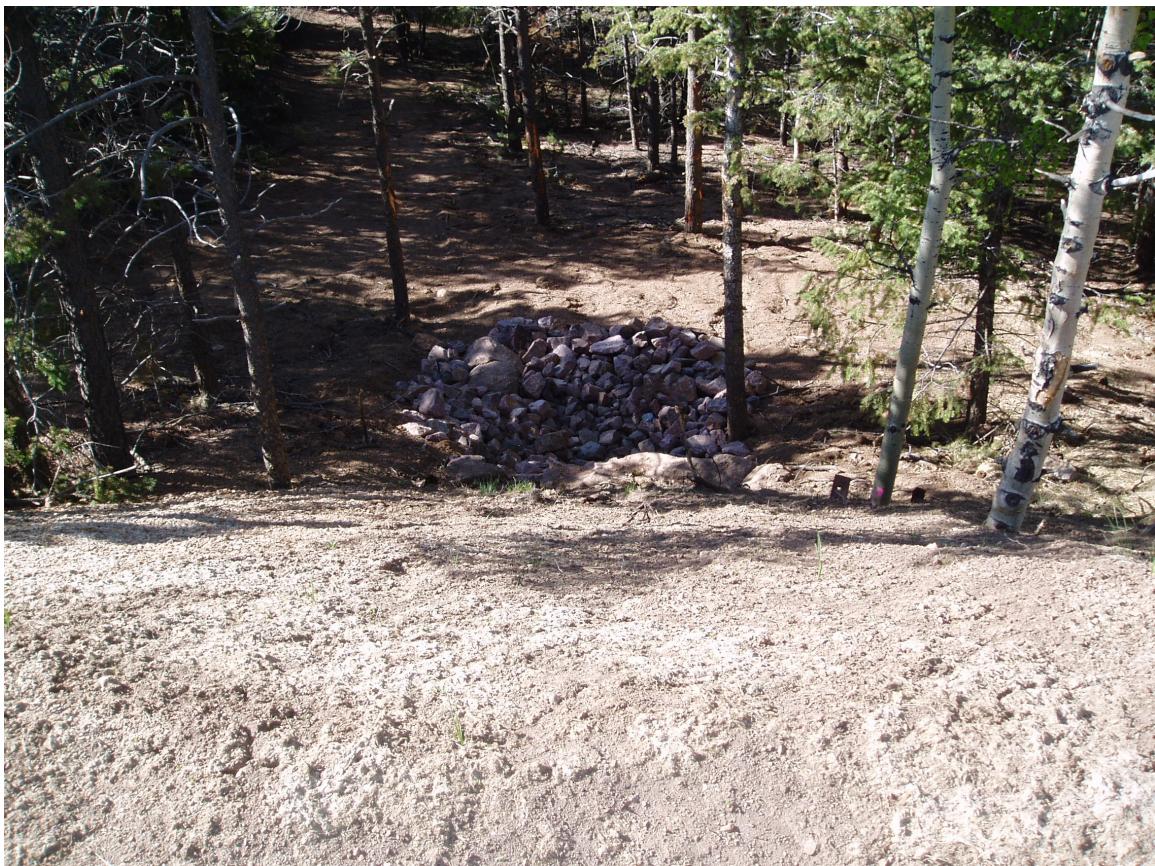
Figure 11. Velocity dissipator near site 007FS and above 175CC, June 2, 2004.

A second location is in Basin 1 near fill slope site 007FS where a curb was installed in 2003 to keep storm drainage off the fill slope. Water flows along the curb to a low point and then is piped down to the base of the fill slope through a culvert and discharged into rip-rap (Figure 11) where it is allowed to flow out over the hill slope. We installed conveyance channel site, 175CC, below the rip-rap on June 2, 2004 prior to any major storm event to measure the effectiveness of the rock in reducing storm drainage energy.

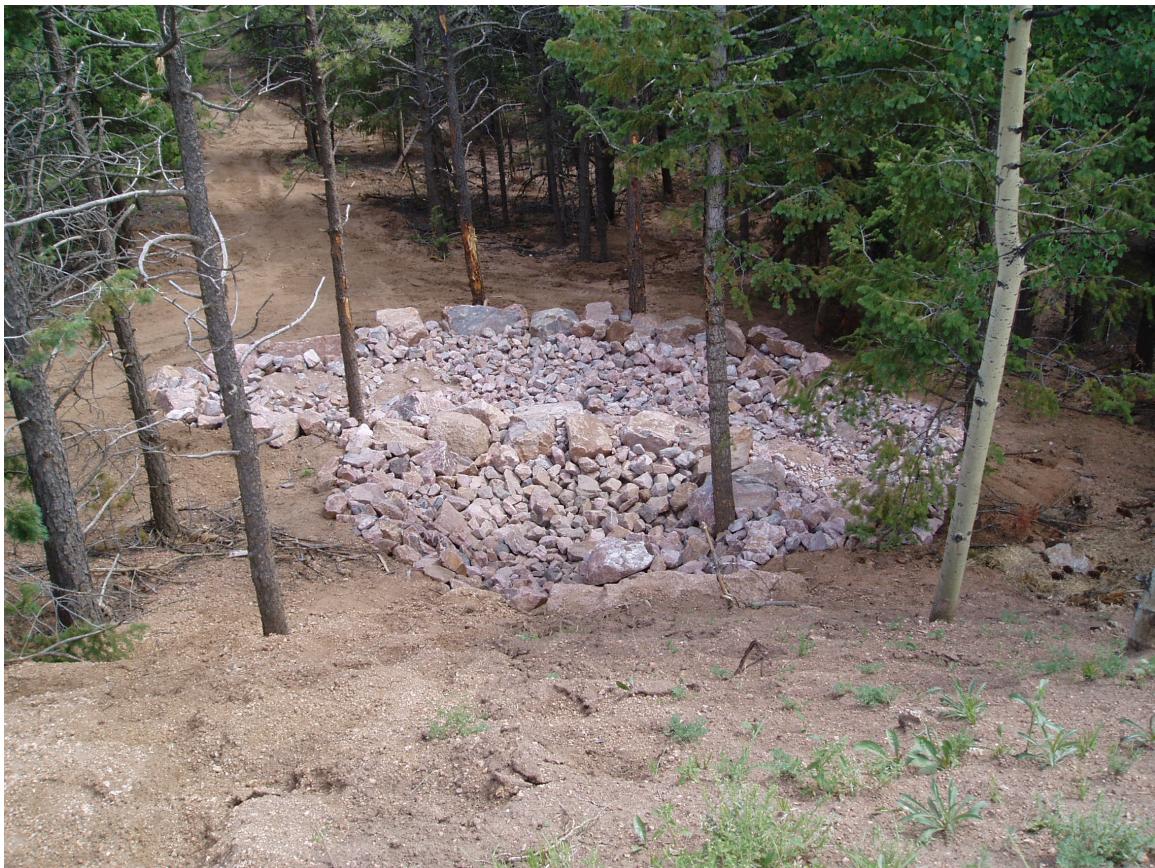
Figure 12. Reconstructed velocity dissipater above 175CC August 3, 2004.

We surveyed 175CC on July (7/21) because the initial rock apron was ineffective at dissipating the energy and a conveyance channel was forming (see Appendix F for surveys of site 175CC). A second July survey (7/30) was performed because the rock apron was enlarged and we needed to reestablish a baseline survey at site 175CC after the construction obliterated the conveyance channel and our cross sections (Figure 12). Visually comparing Figures 11 and 12, you can see the difference in rock size and volume used in the initial versus reconstructed dissipater. The July 30 survey at 175CC will provide a good baseline with which to evaluate the effectiveness of the new, larger dissipater.
