Report on 2006 Field Season

Monitoring the Effectiveness and Validating Response to the Road Related Mitigation Practices Implemented on the Pike's Peak Highway

Fourth Year

**James M. Nankervis
Blue Mountain Consultants
2500 Front Range Ave
Berthoud, CO 80513**

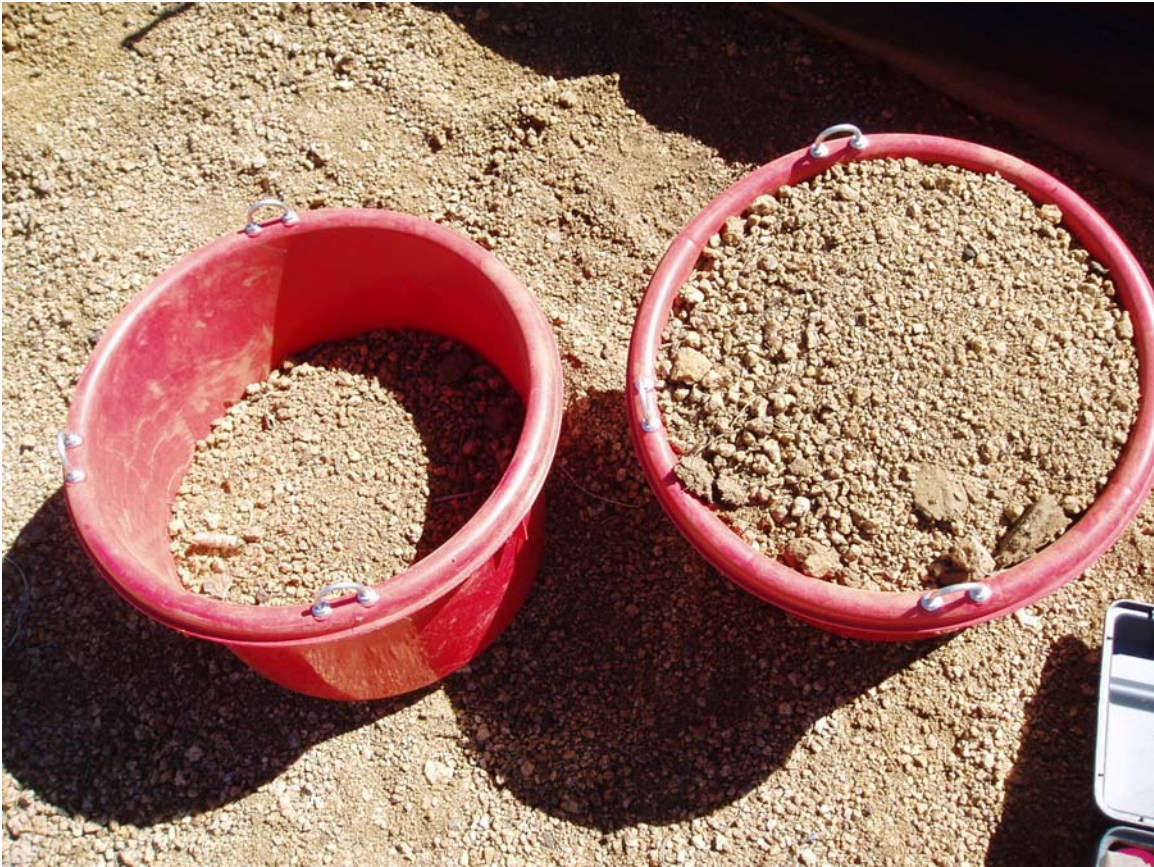
Figure 1. Graduated buckets used to measure excavated material from silt fence sites.

In 2006, thirteen cut slope and 29 fill slope sites were monitored for stability using silt fences to capture eroding material as described by Nankervis (2004). In 2005, we began using graduated buckets to measure volume of material captured by the silt fences. This reduces field surveying time and eliminates the need for data reduction in the office as material is measured directly as it is excavated (Figure 1). An added benefit of this technique is that it can potentially increase sampling frequency as small amounts of material can be measured more efficiently with the bucket than with the survey method. Once again, for the most part, all the silt fences remained intact and functional and only required minimal maintenance or repair. Photographs of all sites are on the data DVD's.

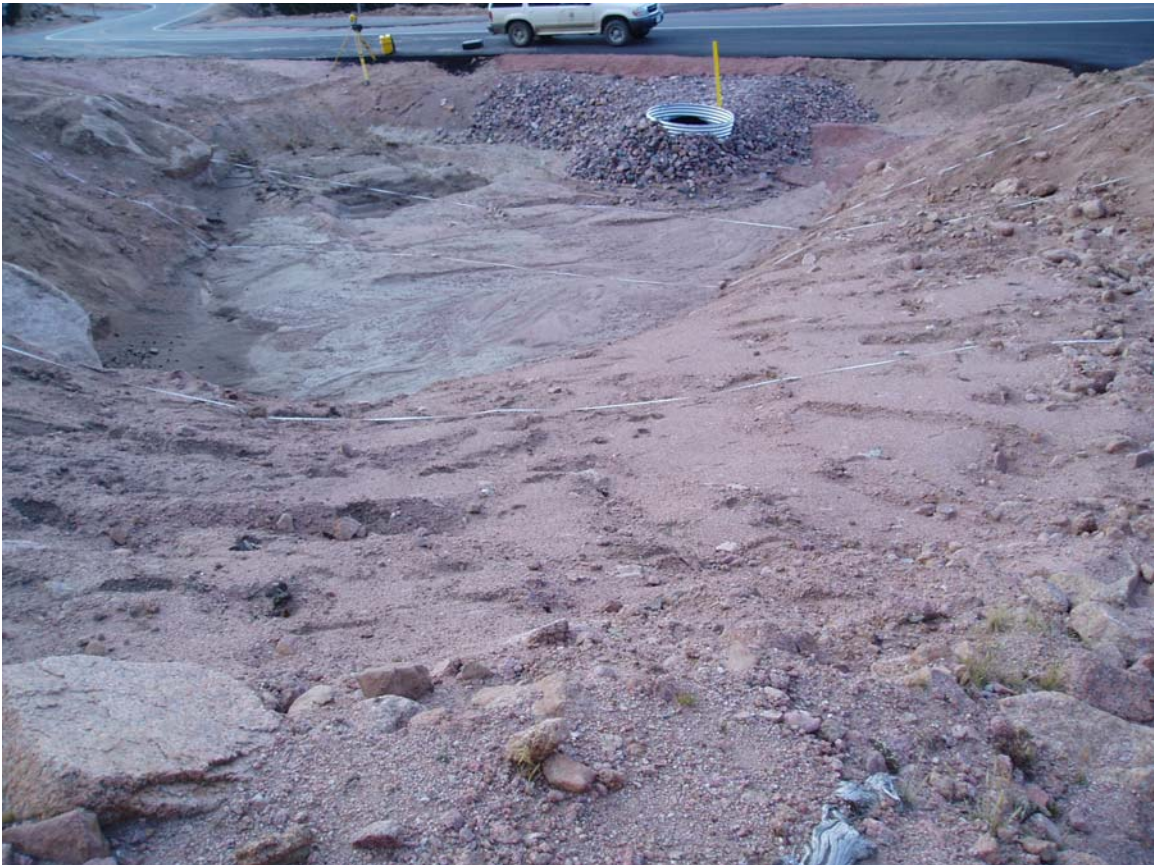
Figure 2. Sediment pond 237RW below Ski Creek diversion wall.

Road runoff enters and exits the smaller pond (237RW) via shot-creted drainage ditches that drain from Severy and Ski Creek drainages into Glen Cove Creek. The pond actually is part of Ski Creek just below the diversion wall built in 2004 and water can also be introduced into the pond if it overtops the diversion. A stand pipe at the base of the pond can spill excess water under the highway and into Ski Creek (Figure 2). The monitoring effort for the pond includes 3 cross sections to estimate volumetric changes in sediment accumulation. Graphs of sediment ponds are in Appendix G.
