## **Annual Progress Report for 2013**

### **MONITORING THE EFFECTIVENESS AND VALIDATING RESPONSE TO THE ROAD RELATED MITIGATION PRACTICES IMPLEMENTED ON THE PIKES PEAK HIGHWAY**

**May 2, 2014**

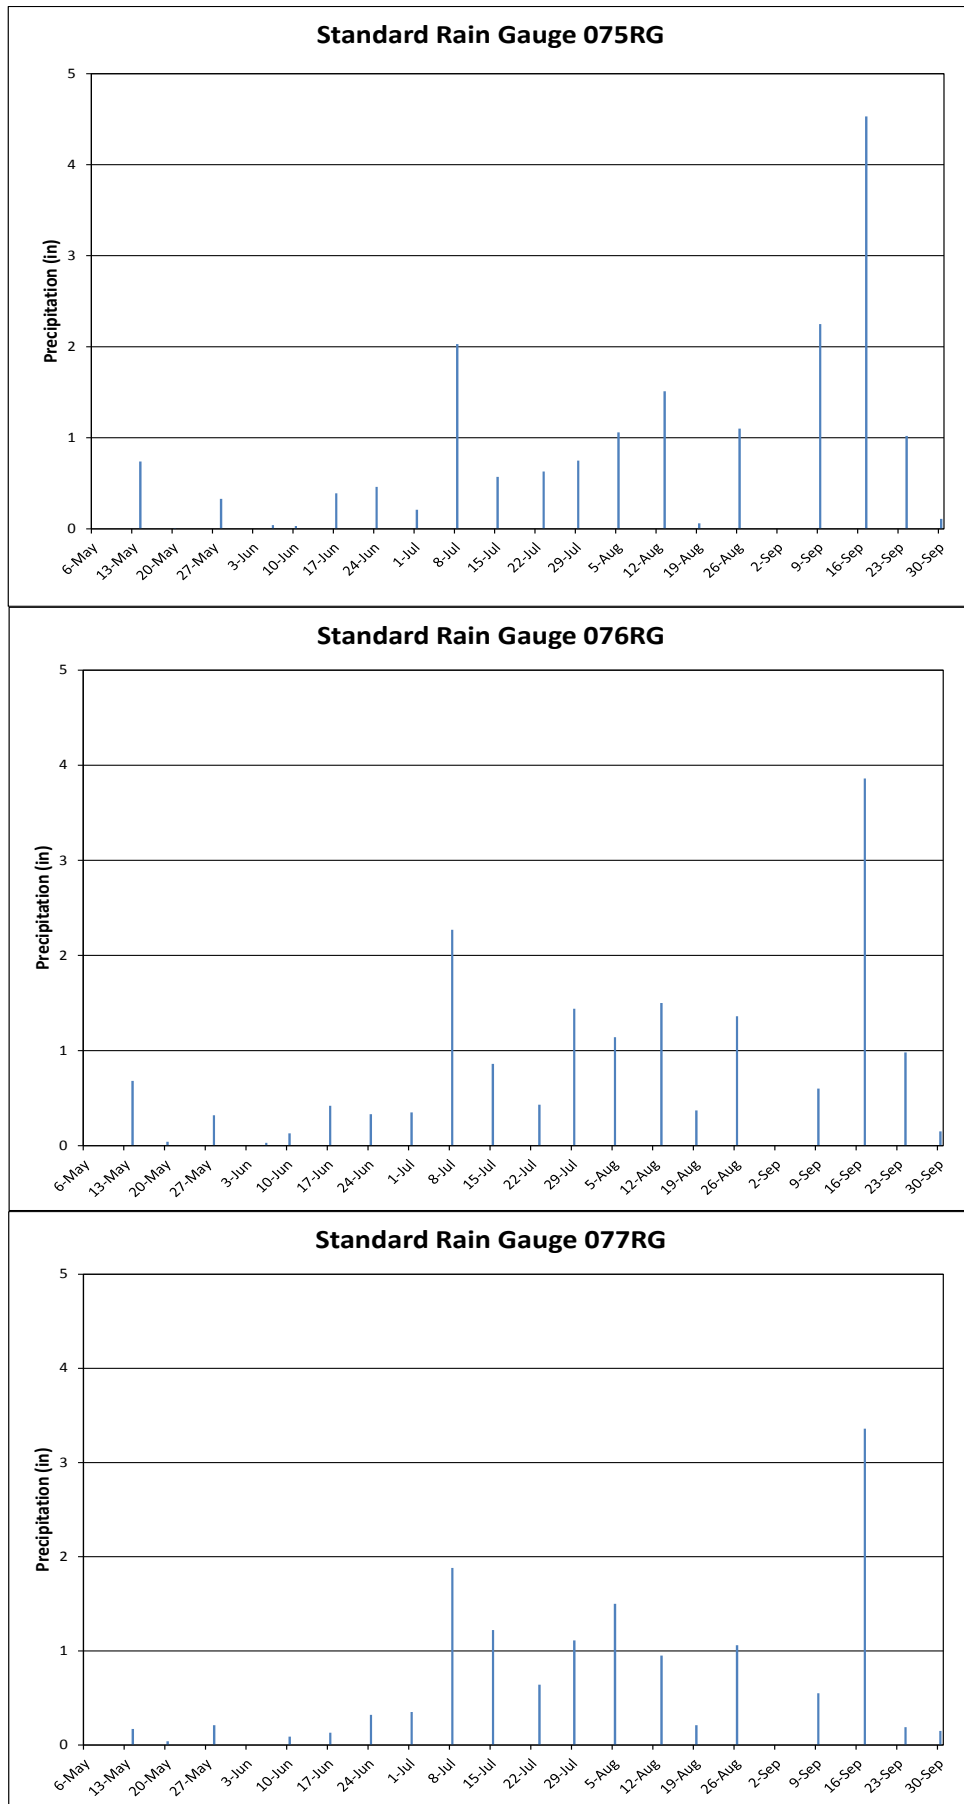
Figure 1. Precipitation by measurement date for the three standard rain gauges on Pikes Peak, 2013.

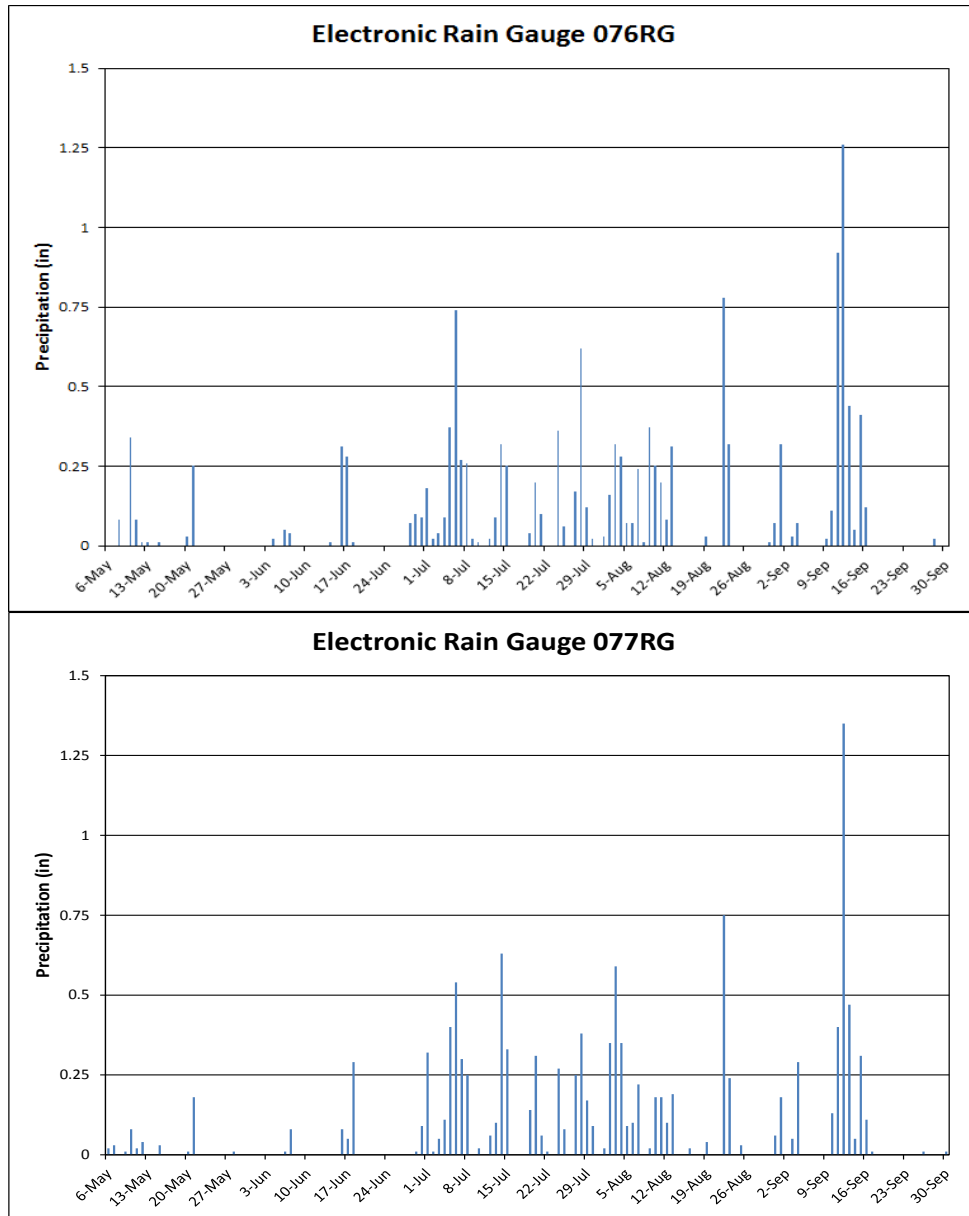
Figure 2. Daily precipitation for two electronic rain gauges on Pikes Peak, 2013.

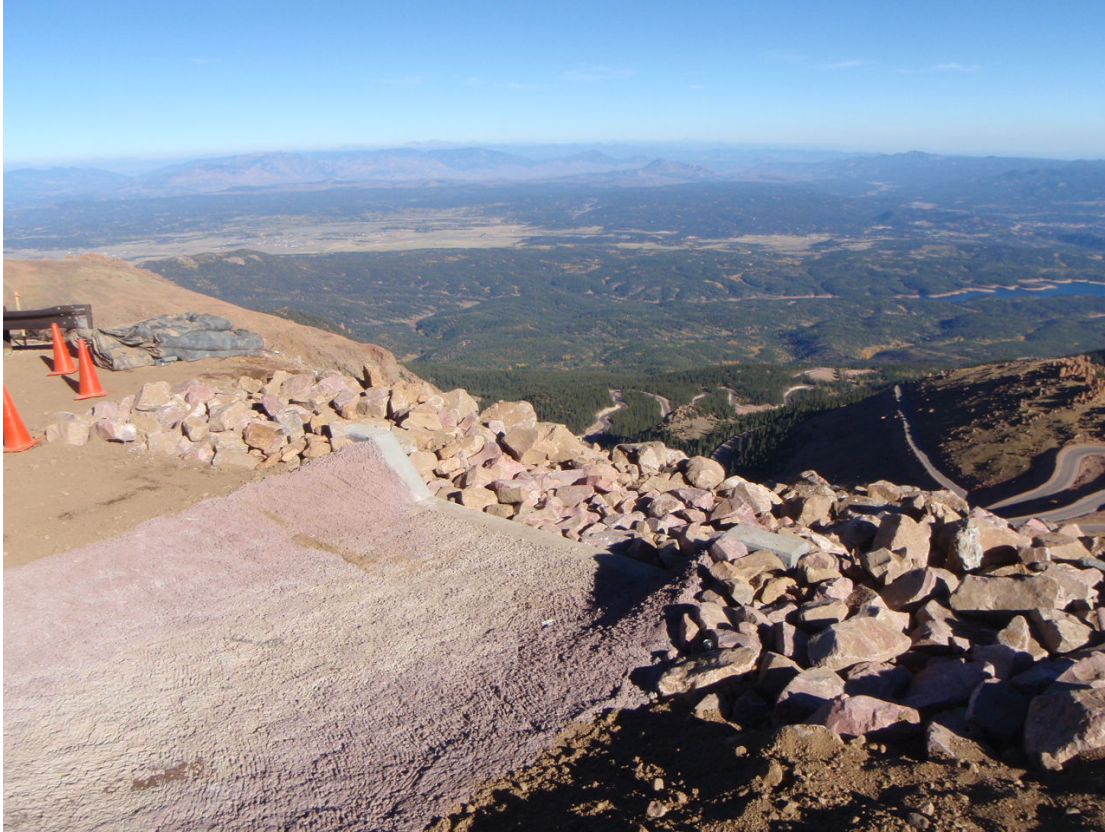
Figure 4. Rock weir 243RW was removed and replaced with cutoff wall with riprap apron below Pikes Peak, 2012.

<sup>∞</sup> Rock weir removed in 2012 and replaced with cutoff wall and riprap apron below.

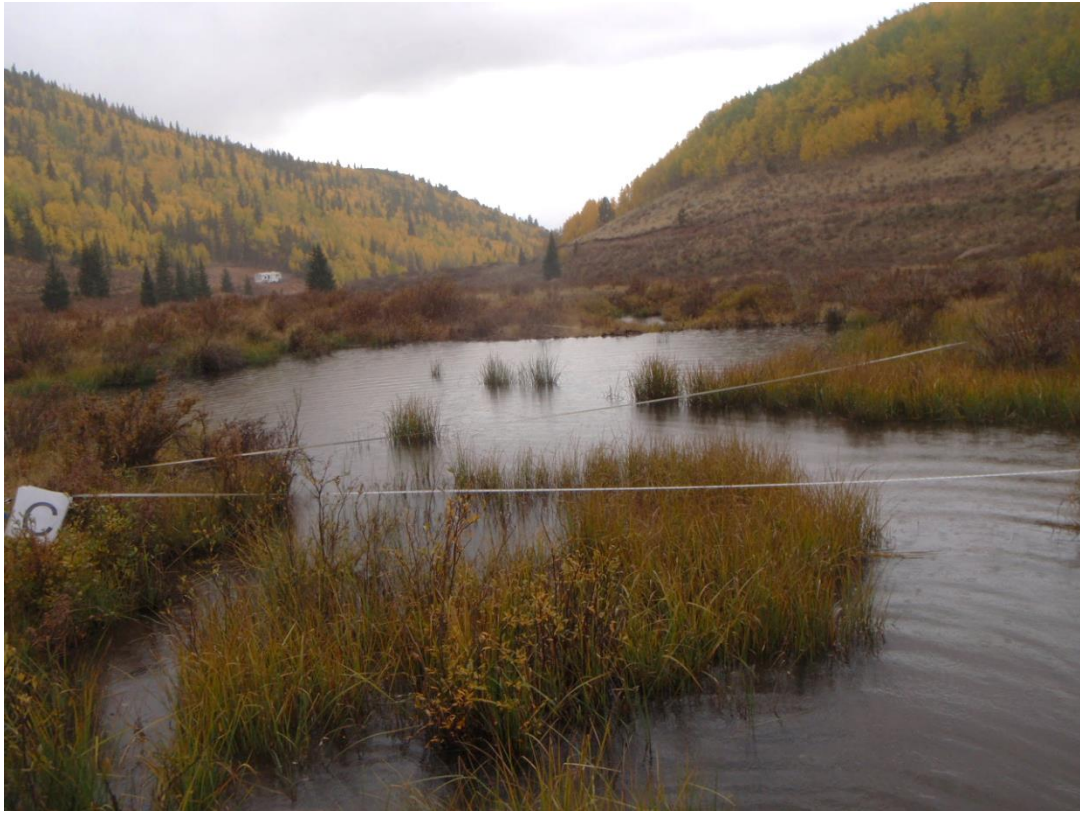
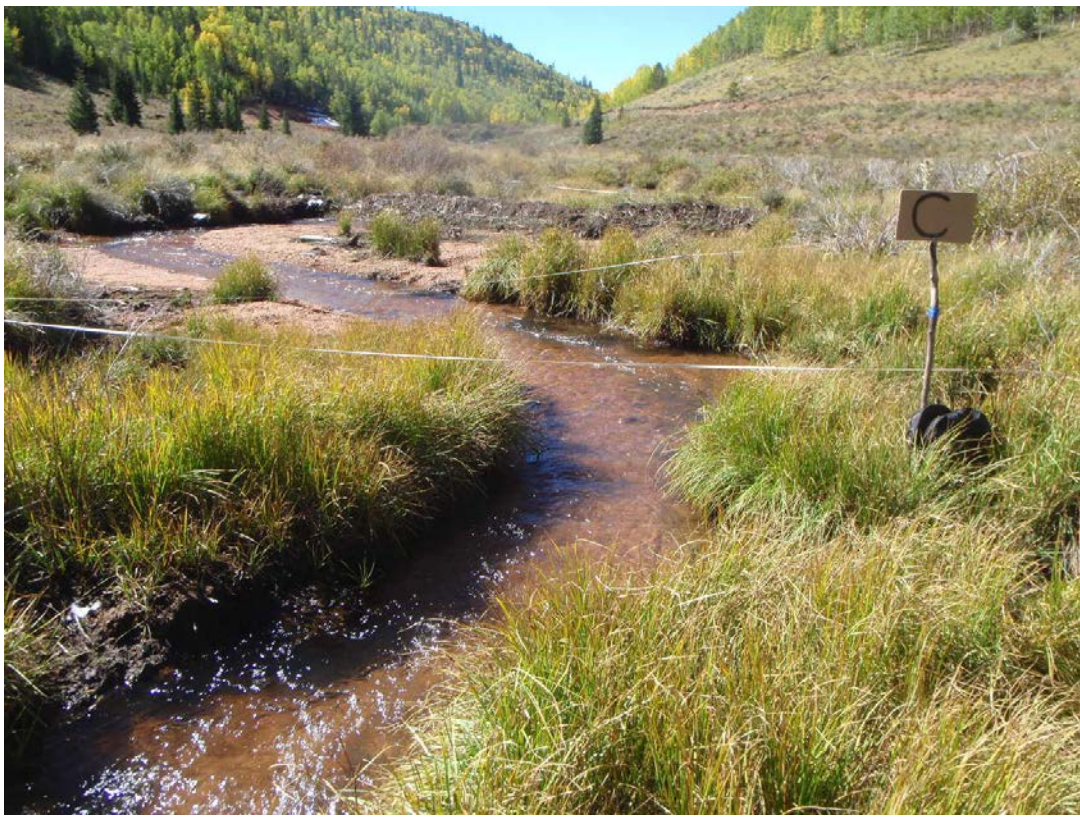
Figure 5. Comparison of Oil Creek in 2012 (top) showing the beaver pond and 2013 (bottom) post flood showing a single stream channel Pikes Peak, 2013.
