Annual Progress Report for 2014

MONITORING THE EFFECTIVENESS AND VALIDATING RESPONSE TO THE ROAD RELATED MITIGATION PRACTICES IMPLEMENTED ON THE PIKES PEAK HIGHWAY

April 13, 2015

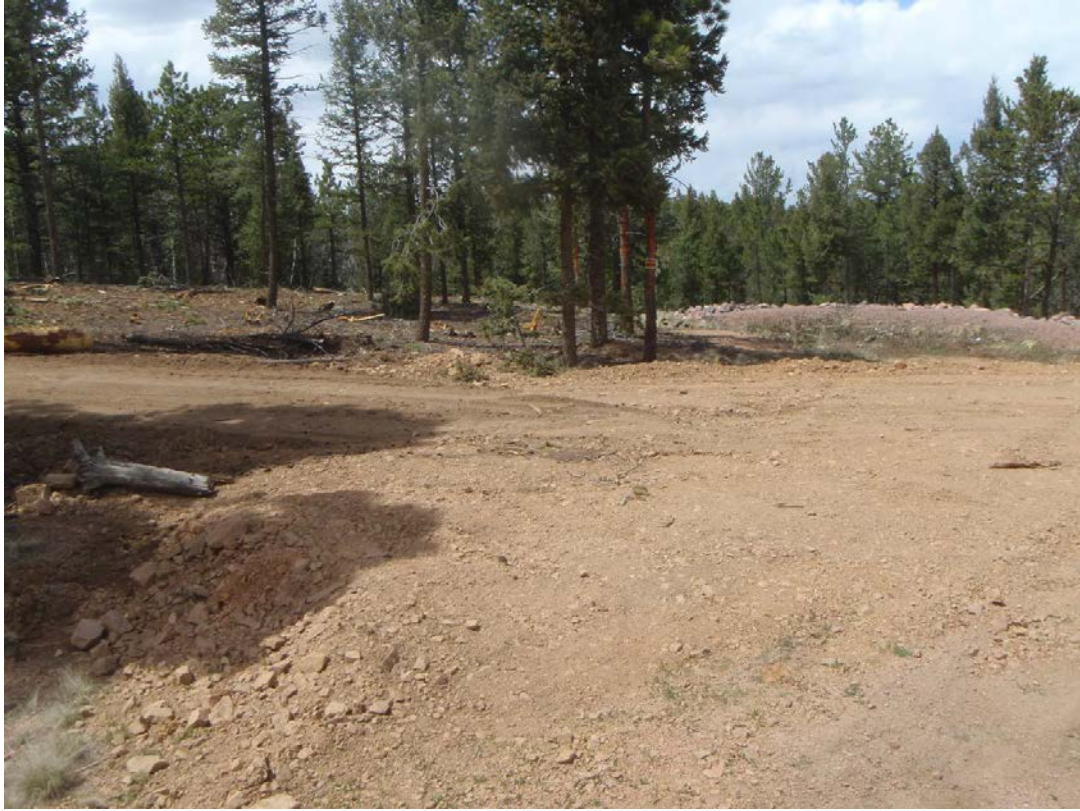
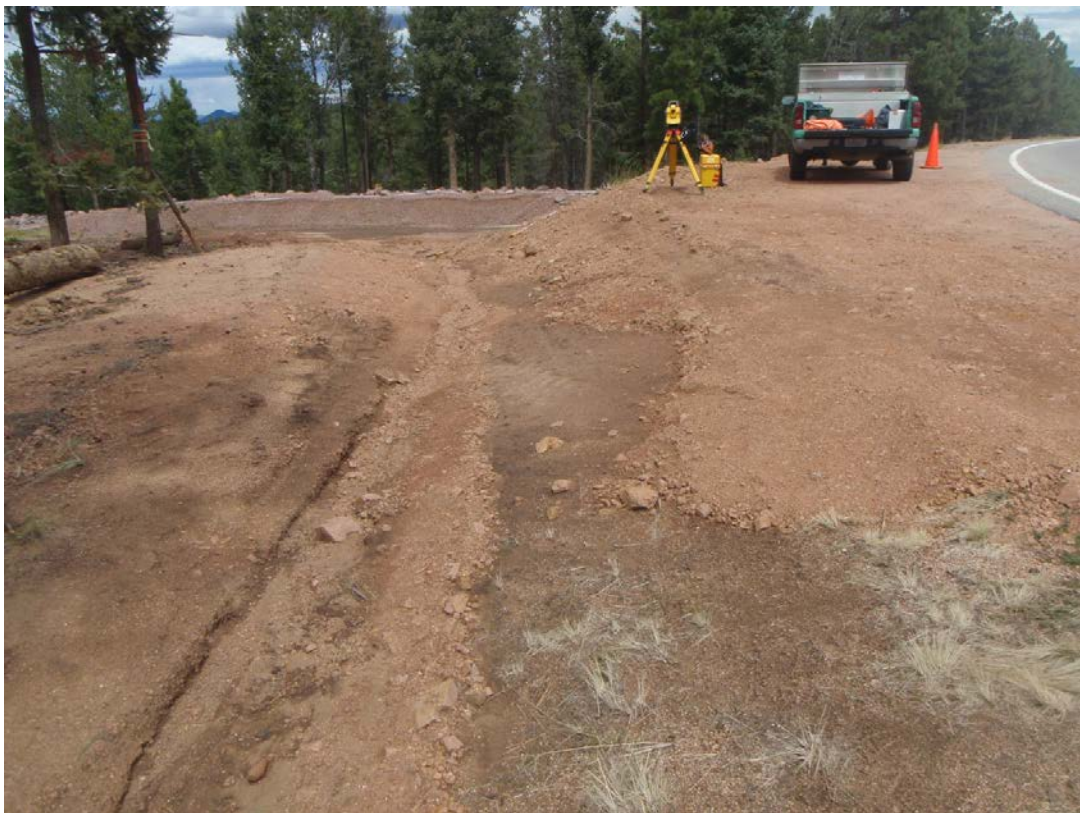
Figure 1. Rock weir 009RA with temporary access road crossing contributing ditch (top) and drainage ditch after removal of material at the end of the field season (bottom), Pikes Peak 2014.

The access road was also decommissioned and restored. Five successional rolling dips were built on the road bed to decelerate and divert runoff onto the adjacent hill slope. The soil on the road was agitated to promote new vegetation growth. The field crew replaced three benchmarks damaged by logging equipment and completed a post restoration survey of 009RA once the highway crew completed repairs.

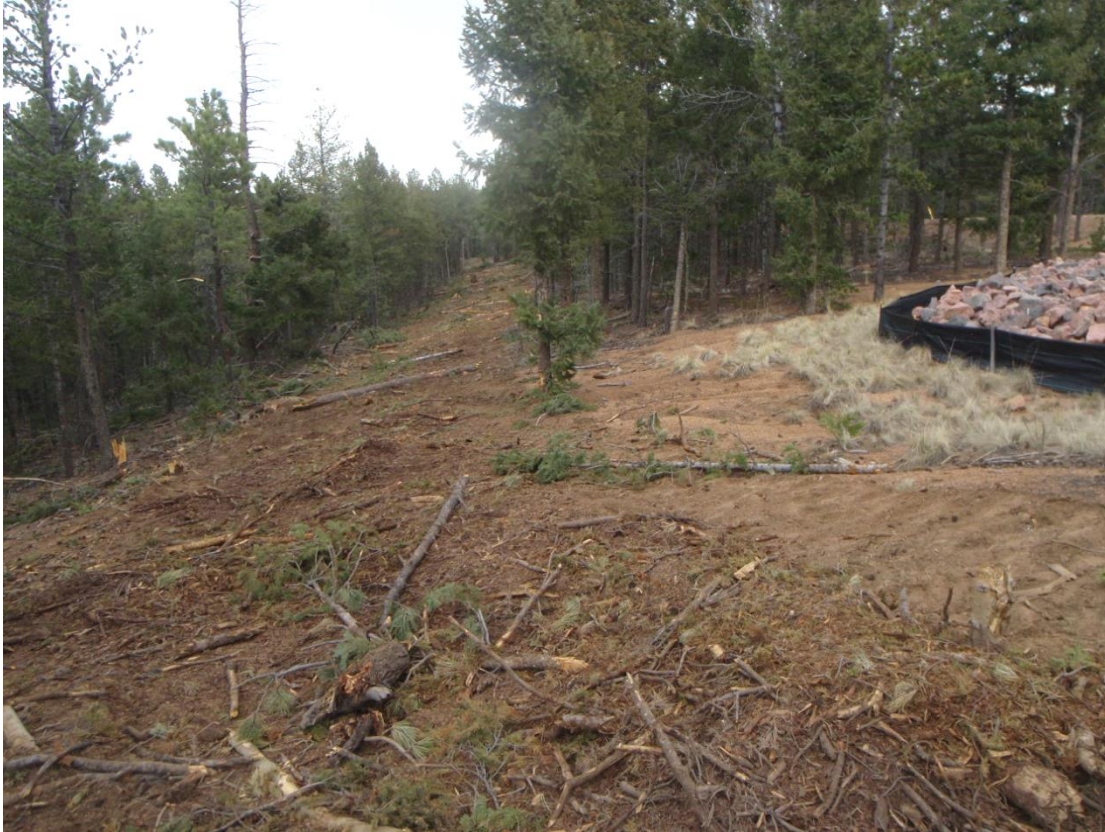
Figure 2. Clear cut break below rock weir 009RA encompassing cross sections of conveyance channel 223CC, Pikes Peak 2014.

In addition to the clear cut units, clear-cut breaks, or swaths, were also created. The breaks parallel the highway and cross monitoring sites as most of the conveyance channels and rock weirs are perpendicular to the highway (Figure 2). This compromises the integrity of some monitoring sites and may compromise the ability to obtain valid measurements at some of those sites. A list of the rock weir and conveyance channel cross sections potentially compromised by the silvicultural activities and associated disturbances can be found in Table 2. The designation directly impacted implies disturbance has occurred on or near the monitoring site, while the designation potentially impacted refers to sites not located in the disturbance area but close enough that they may be compromised.

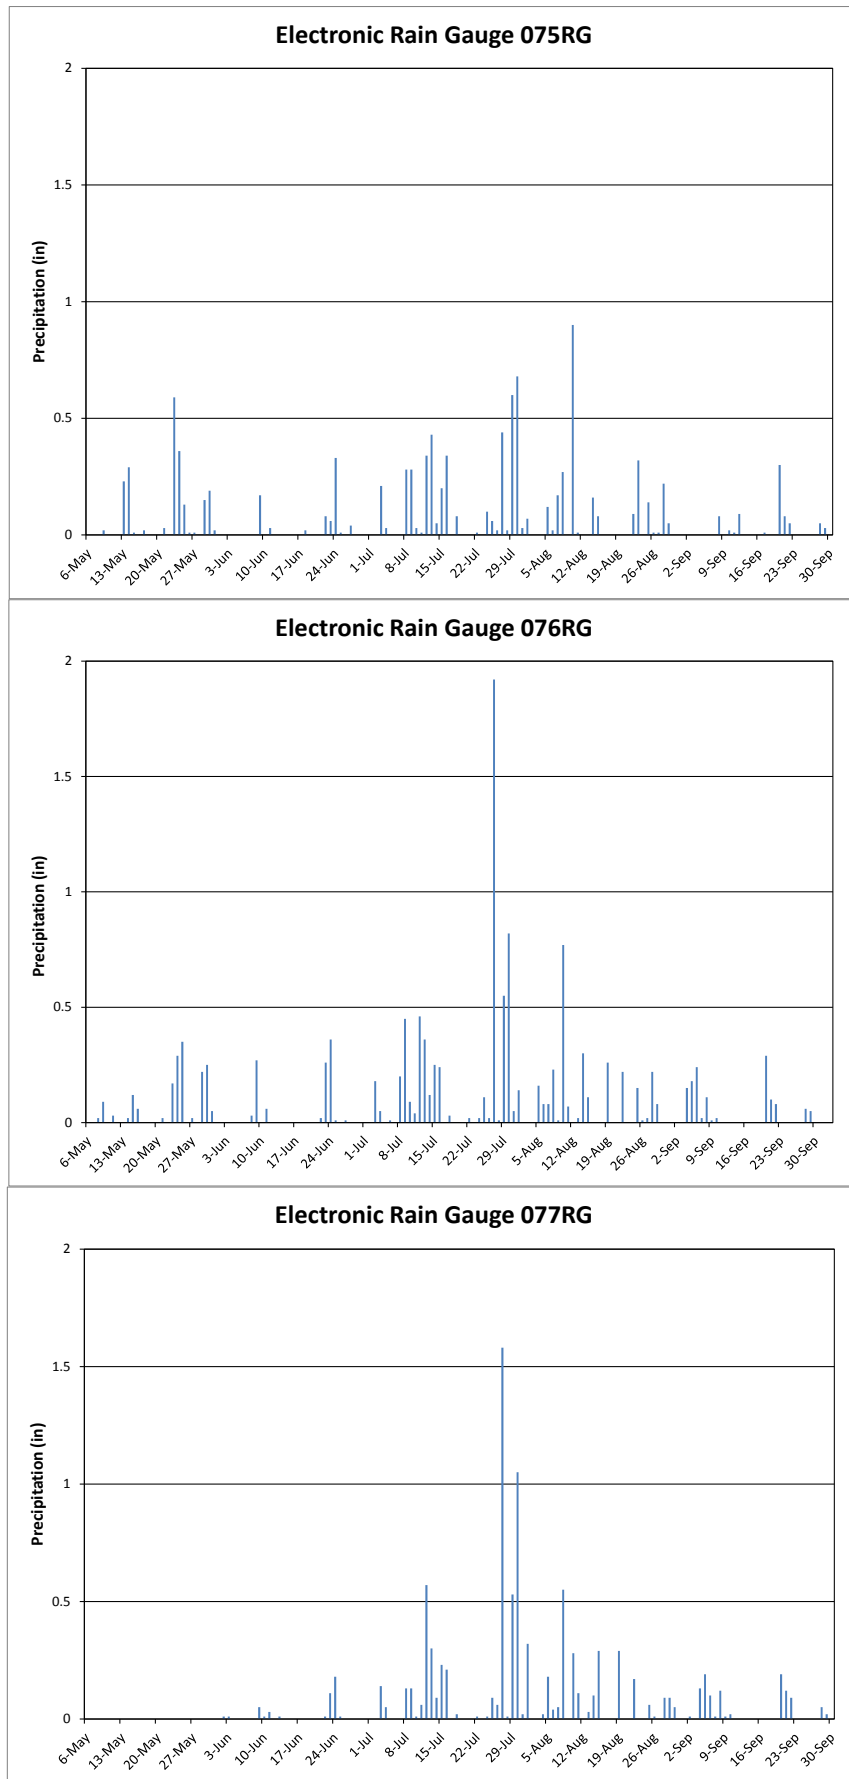
Figure 3. Daily precipitation for three electronic rain gauges, Pikes Peak 2014.

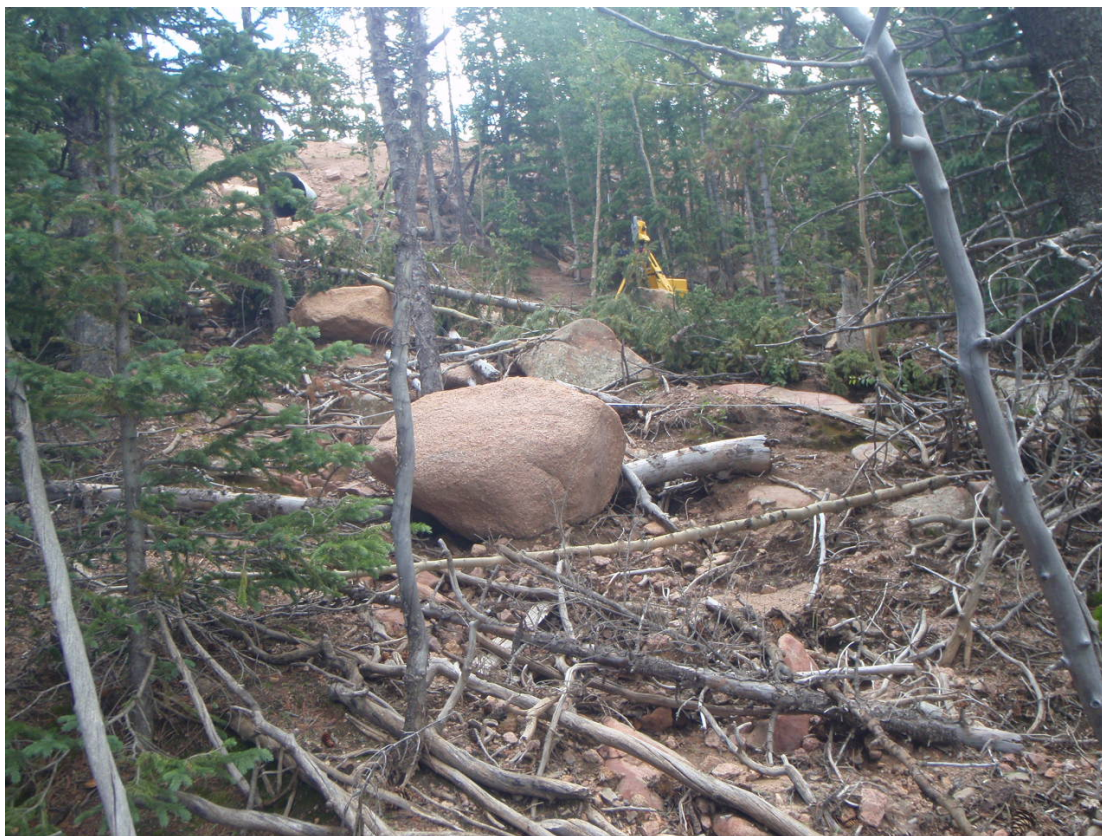
Figure 5. Conveyance channel 064CC showing boulders and trees above cross section C after vehicle crash during the Hill Climb, Pikes Peak 2014.

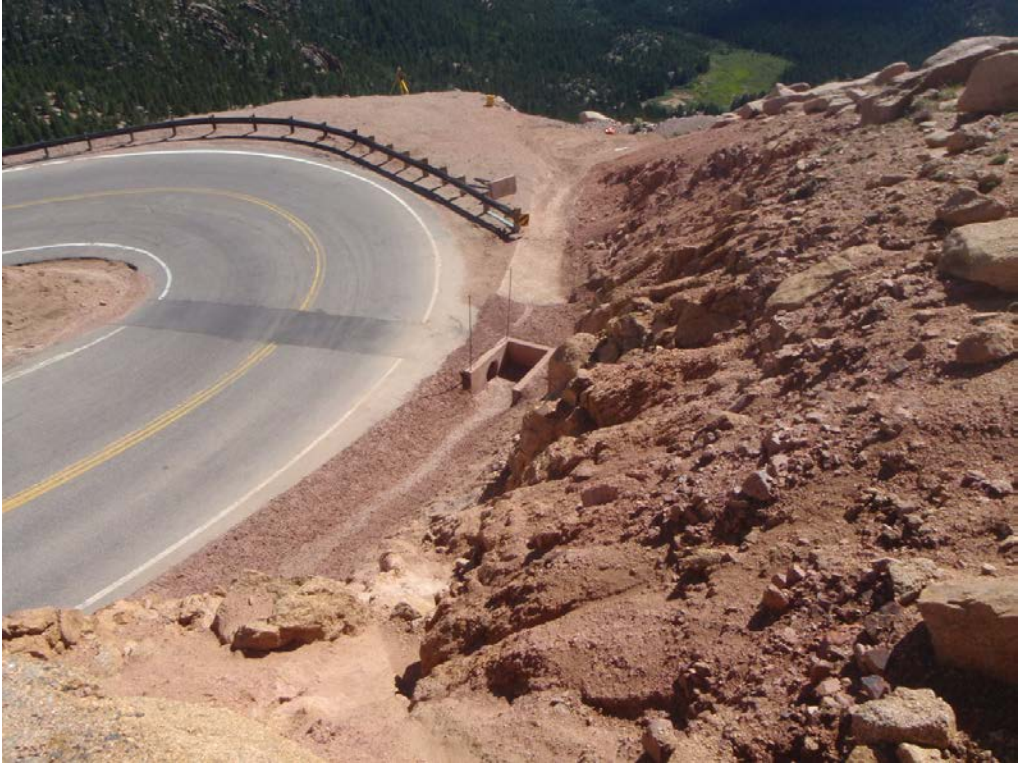
Figure 6. Pipe back under the highway above rock weir 234RW which diverts water entering Severy Creek to a shotcrete ditch above sediment pond 237RW which flows into Ski Creek, Pikes Peak 2014.

In 2014, a private contractor for the City of Colorado Springs installed a pipe back system above rock weir 234RW (Basin 3) to divert water under the highway to a shotcrete ditch above sediment pond 237RW (Figure 6). This diverted drainage from Severy Creek Watershed to Ski Creek Watershed. In 2012, the highway crew removed five breached rock weirs (236RW, 238RW, 240RW, 242RW, and 243RW) in the switchbacks (Basins 3 and 4: Upper Ski and North French Creeks) and replaced them with cutoff walls with riprap aprons below (Figure 7). Photographic and observation monitoring are used to document changes at these sites along with three sediment ponds (258RW, 260RW, and 262RW). As noted earlier, rock weirs 002RW, 003RW, 006RW, and 009RA may have been compromised by the Crystal Creek Fuels

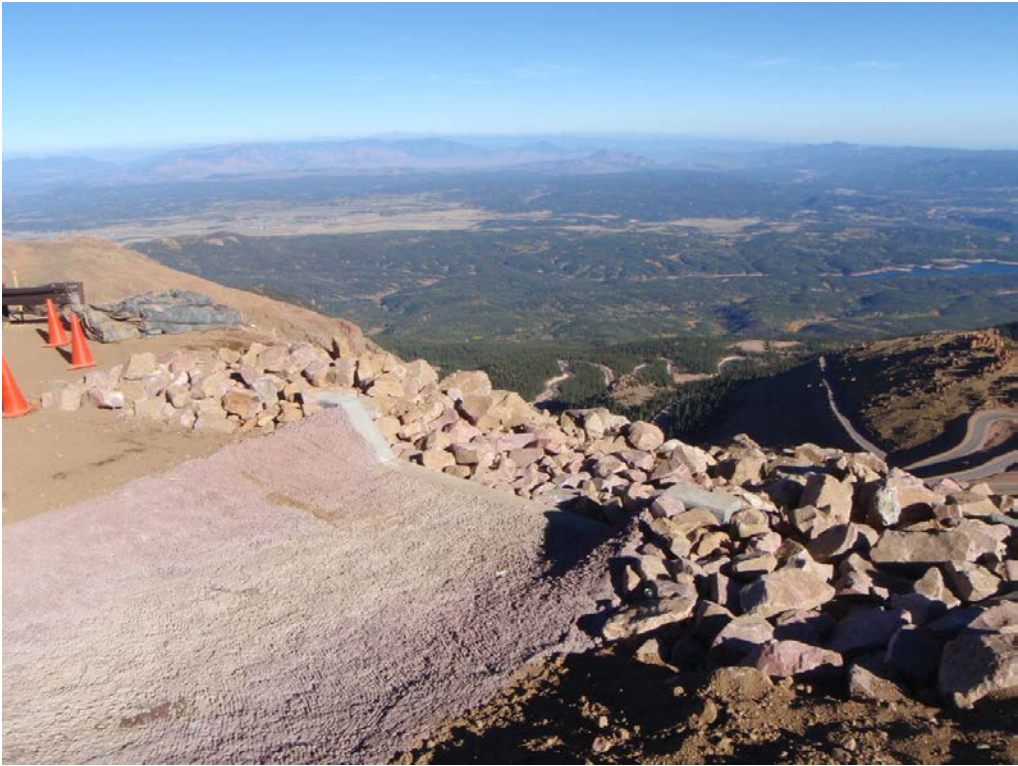
Figure 7. Rock weir 243RW was removed and replaced with cutoff wall with riprap apron below, Pikes Peak 2012.

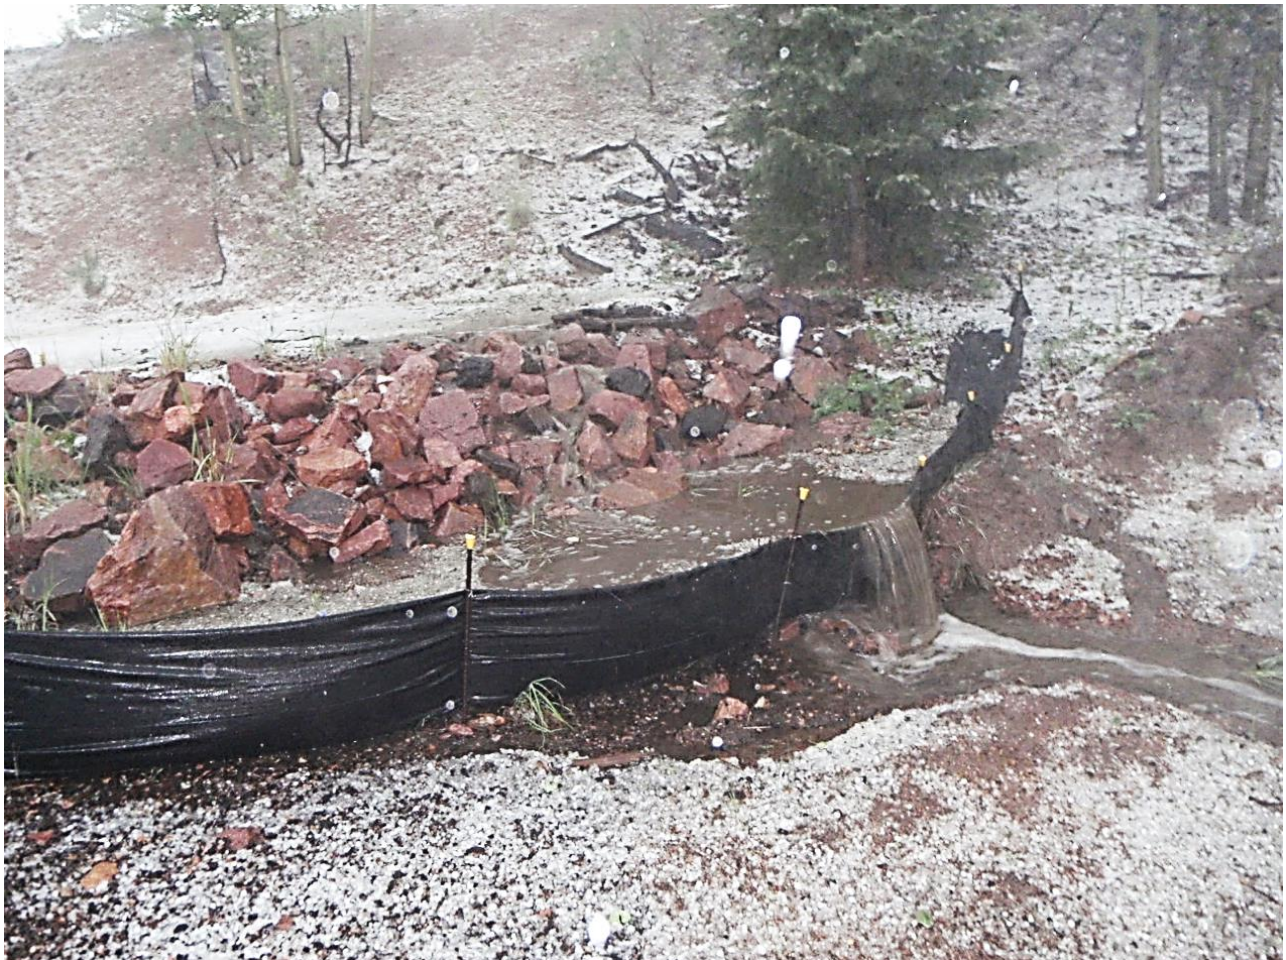
Figure 8. Rock weir 202RW overtopping during storm event on July 8, Pikes Peak 2014.

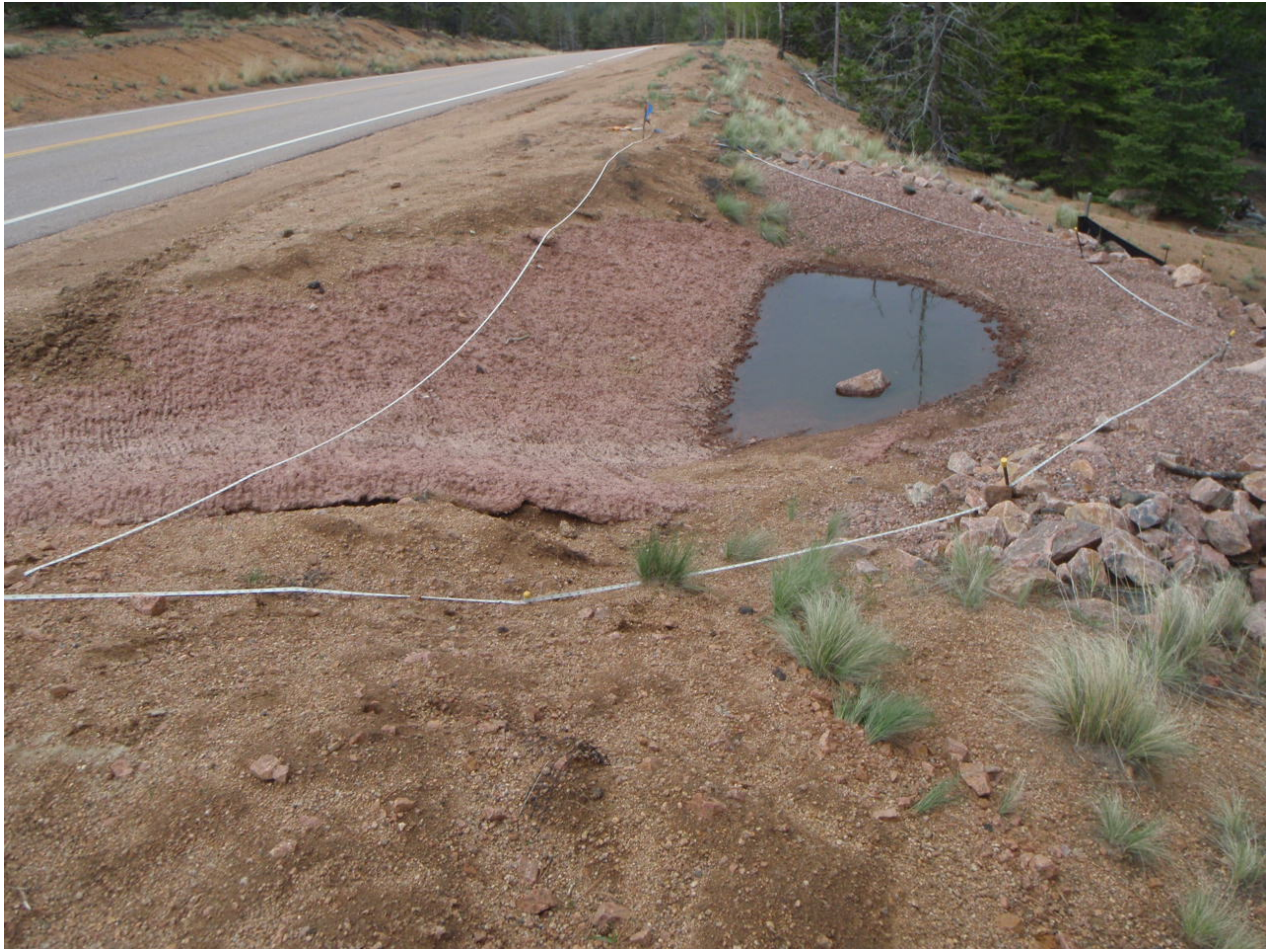
Figure 9. Rock weir 176RW lined with shotcrete and filled with standing water. The high flow is causing the shotcrete to be undercut, Pikes Peak 2014.

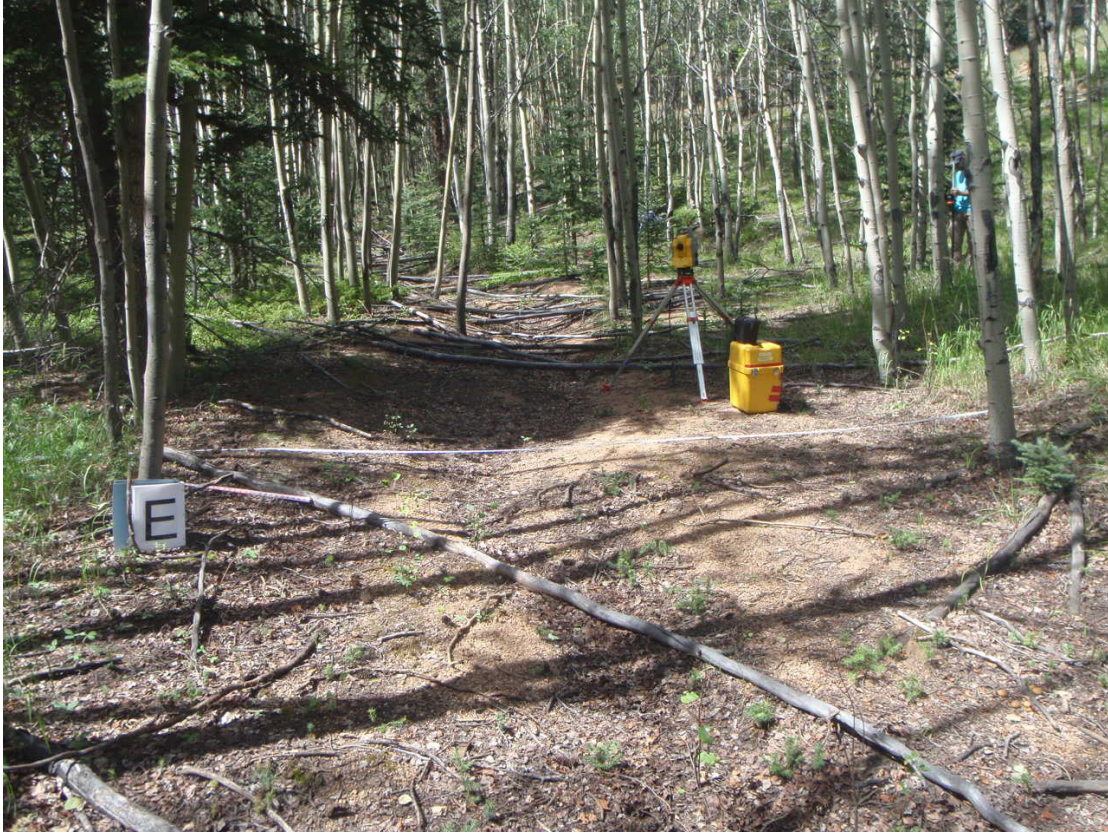
Figure 10. North Fork Crystal Creek Reach 2 showing re-vegetation of stream bed and stream bar at cross section E, Pikes Peak 2014.
