Annual Progress Report for 2015

MONITORING THE EFFECTIVENESS AND VALIDATING RESPONSE TO THE ROAD RELATED MITIGATION PRACTICES IMPLEMENTED ON THE PIKES PEAK HIGHWAY

April 4, 2016

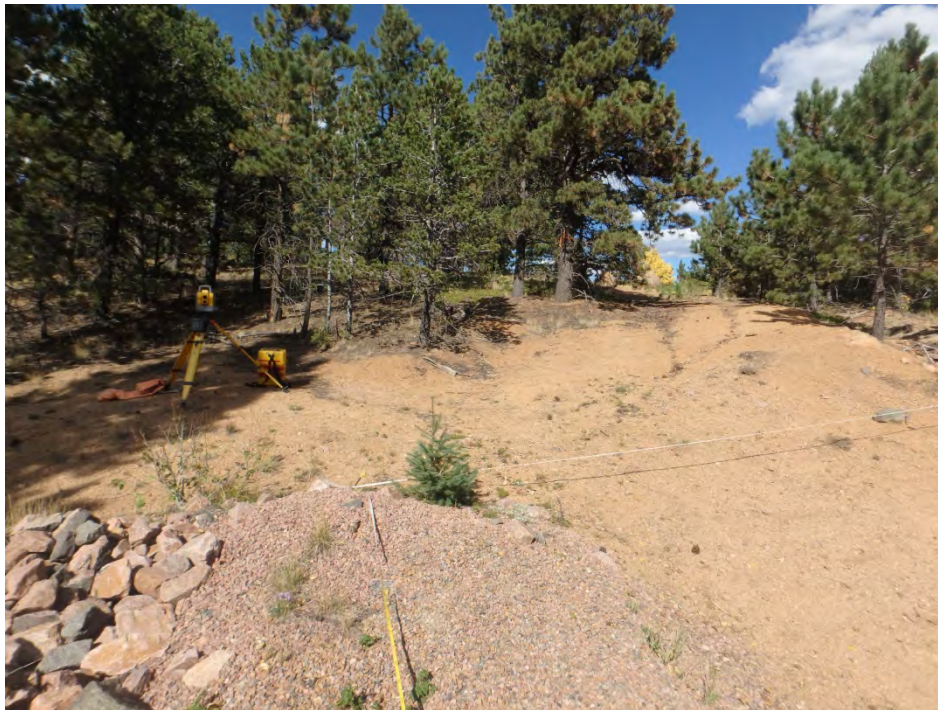
Figure 1. Rock weir 153RW showing bare apron above rock weir that could be aggravated if disturbed or stabilized, Pikes Peak 2015.

The U.S. Forest Service, South Catamount Creek Fuels Reduction Project in Basin 2 (North Fork of Crystal and Ski Creek Watersheds) is in its initial stages and is scheduled for tree remediation in 2016. This treatment is planned to be accomplished by hand work, and will most likely consist of tree felling, and subsequent lop and scattering of slash. Rock weirs 152RW and 153RW and their associated conveyance channels are located in the area proposed for treatment. The apron above rock weir 153RW is primarily bare, highly erosive Pikes Peak granite that could be aggravated if disturbed, or stabilized if covered with lopped and scattered slash (Figure 1). The latter would normally be considered beneficial, but the response to either disturbance or stabilization would potentially alter the response currently being monitored at this site.

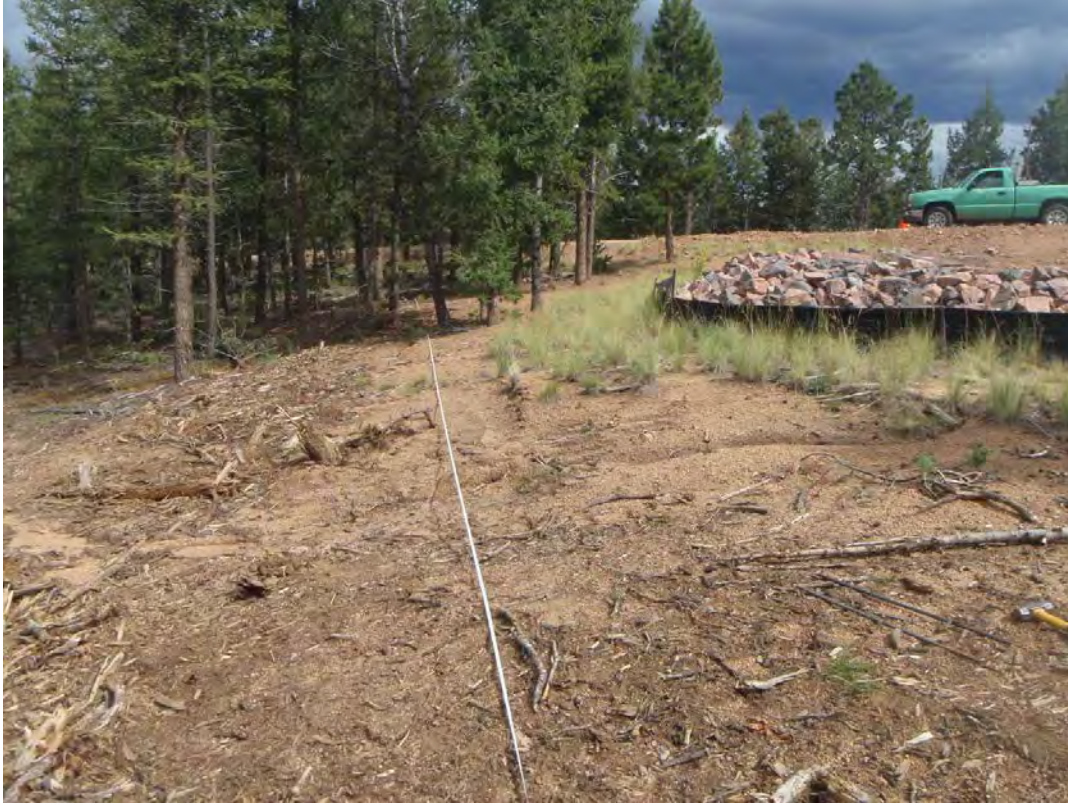
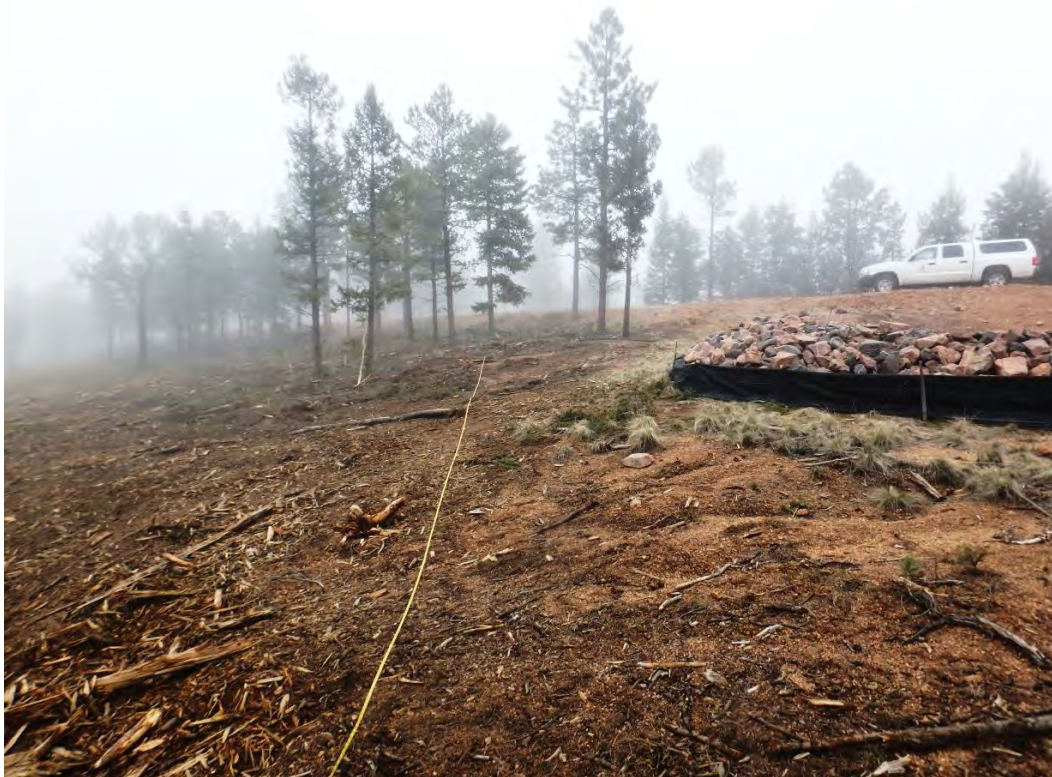
Figure 2. Clear cut break below rock weir 009RA encompassing cross sections of conveyance channel 223CC that was forested prior to 2014 (above) and after additional treatment 2015 (below), Pikes Peak 2015.

In the winter of 2014/2015, additional work was completed on the Crystal Creek Fuels Reduction Project. Treatment included forest thinning and mastication; creating a three to six-inch layer of woody debris. This additional work impacted four previously impacted sites and five new sites. Figure 2 shows a comparison of conveyance channel 221CC in 2014 and 2015 before and after additional work was completed. A list of the rock weir and conveyance channel cross sections potentially compromised by the silvicultural activities and associated disturbances can be found in Table 1.

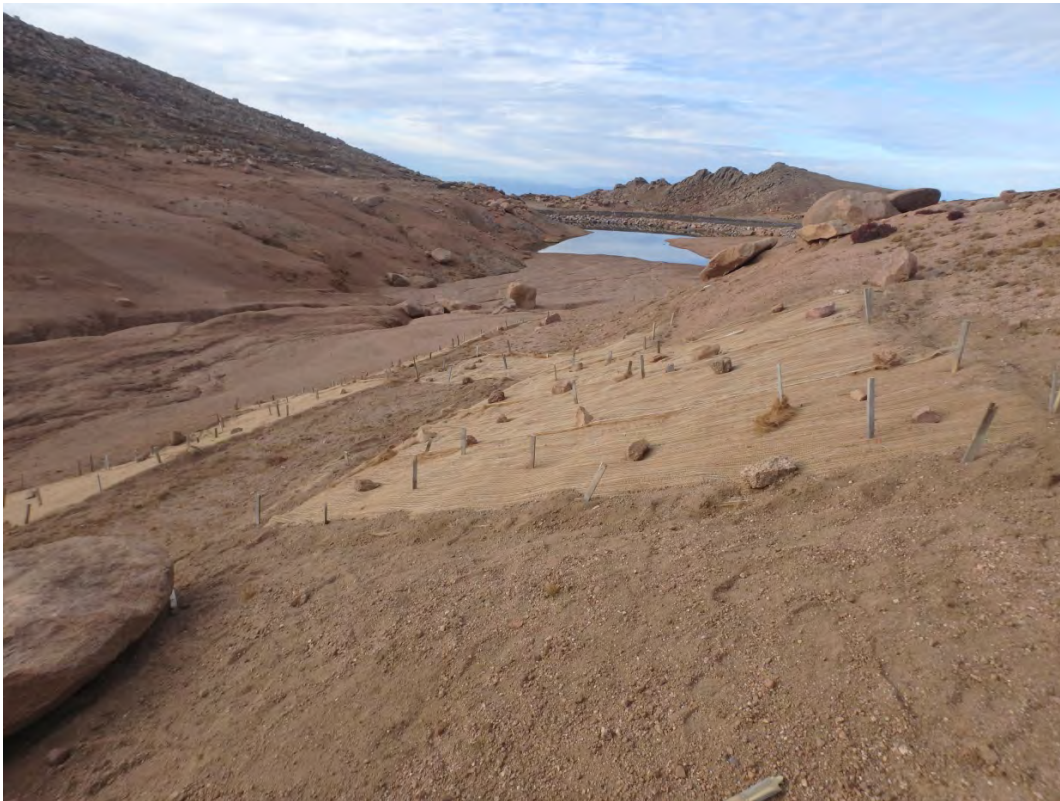
Figure 3. RMFI planted native seeds and installed erosion control fabric on the hill slope along the highway drainage flowing into sediment pond 258RW.

Work in 2015 completed by the Rocky Mountain Field Institute (RMFI) focused primarily above timberline around sediment ponds 258RW and 260RW. Native seeds were planted and erosion control matting installed on hill slopes exceeding a 20 percent gradient along highway drainages (Figure 3). RMFI used Mile High Corps and community volunteers to complete the 2015 projects. Restoration activities such as these are often environmentally positive, but can be at

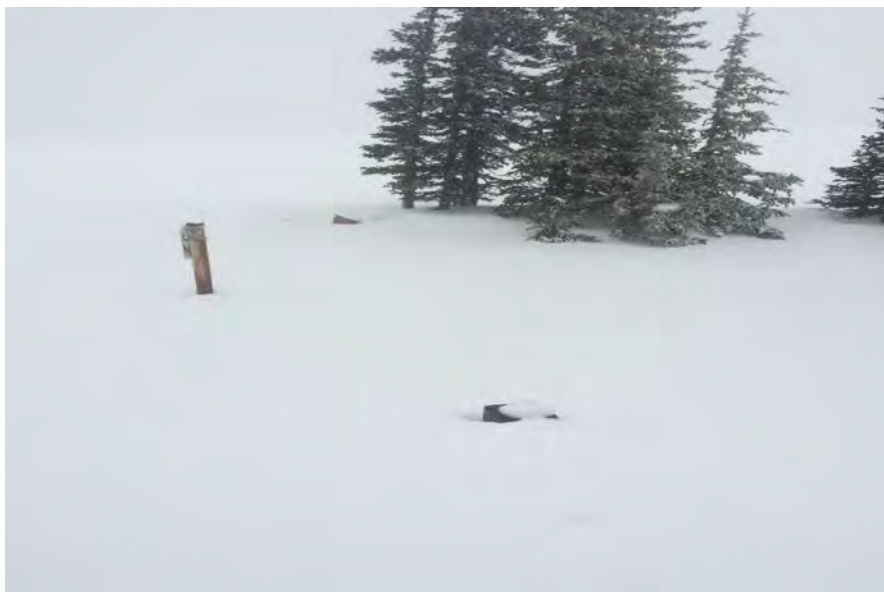
Figure 4. Electronic rain gauge 076RG 1.5-feet above snowline and standard rain gauge 076RG post buried in large snow drift, Pikes Peak, May 2015.

In 2015, the three tipping bucket rain gauges and standard rain gauges were installed by May 5, but due to freezing temperatures and heavy snowfall, the electronic rain gauge tipping mechanisms froze and the standard rain gauges cracked (Figure 4). As a result, no usable data was obtained until June 1. The standard, non-recording rain gauges (All-Weather) are installed at each site as described in the 2010 Annual Report. The standard rain gauges provide a second index of precipitation amount for the sampling interval to avoid loss of data should a tipping bucket rain gauge fail.

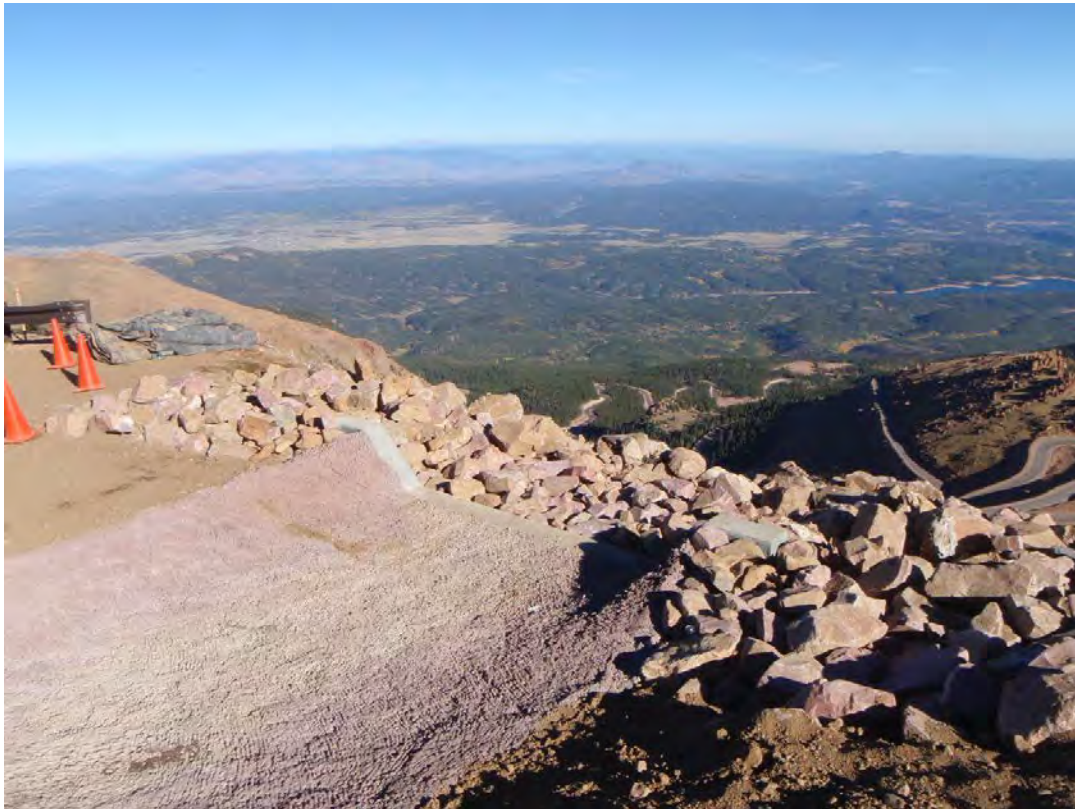
Figure 7. Rock weir 243RW was removed and replaced with cutoff wall with riprap apron below, Pikes Peak 2012.

In 2012, the highway crew removed five breached rock weirs (236RW, 238RW, 240RW, 242RW, and 243RW) in the switchbacks (Basins 3 and 4: Upper Ski and North French Creeks) and replaced them with cutoff walls with riprap aprons below (Figure 7). Photographic and observation monitoring are used to document changes at these sites along with three sediment ponds (258RW, 260RW, and 262RW). As noted earlier, rock weirs 002RW, 003RW, 006RW, 008RW, and 009RA, or their contributing area, may have been compromised by the Crystal Creek Fuels Reduction Projects. Additionally, rock weirs 152RW and 153RW within the South Catamount Fuels Reduction Project area have been identified as “at risk” if directly impacted by the proposed treatment.

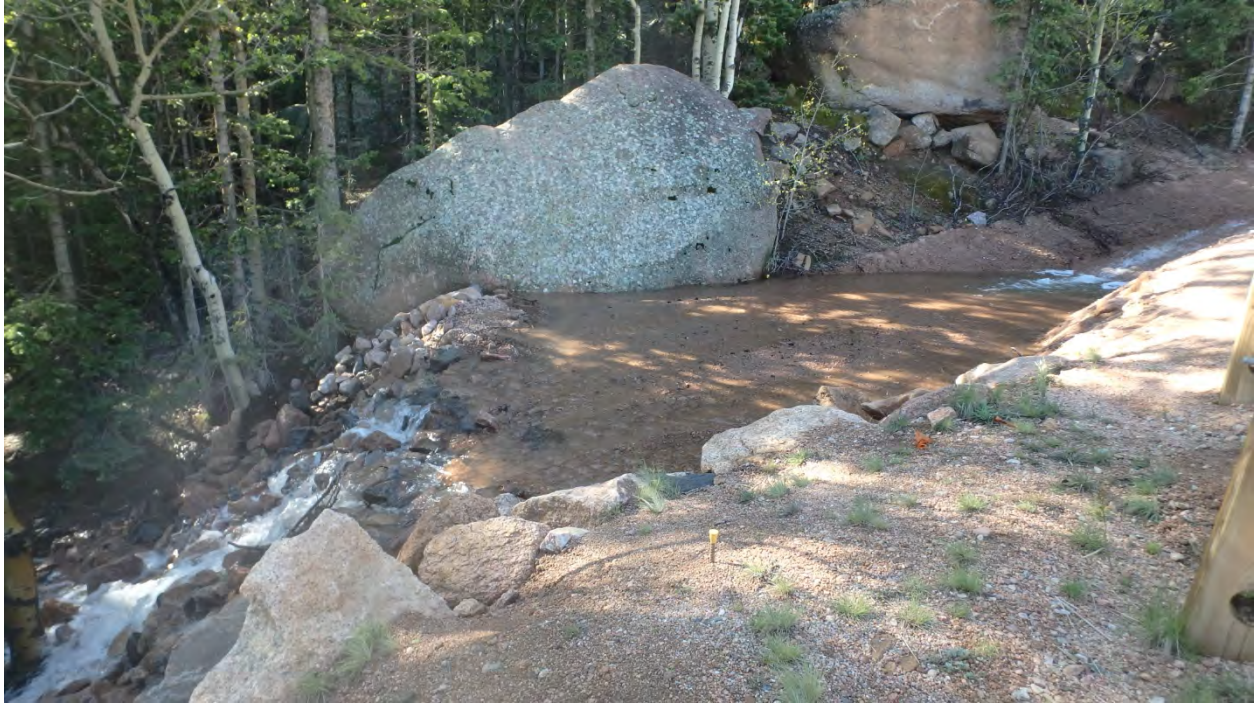
Figure 8. Rock weir 252RW filled with sediment and overtopping during spring runoff, Pikes Peak June 16, 2015.

Thirty-two sediment traps were monitored in 2015, including 20 rock weirs, seven sediment ponds, and five cutoff walls with riprap aprons below. Seventeen sites were surveyed at least twice to monitor trapped sediment from winter and summer runoff. All 20 rock weirs were surveyed and sediment volume was measured in the silt fences located down slope of 15 rock weirs. Seven of the 20 rock weirs overtopped during all rain events throughout the field season (Figure 8).

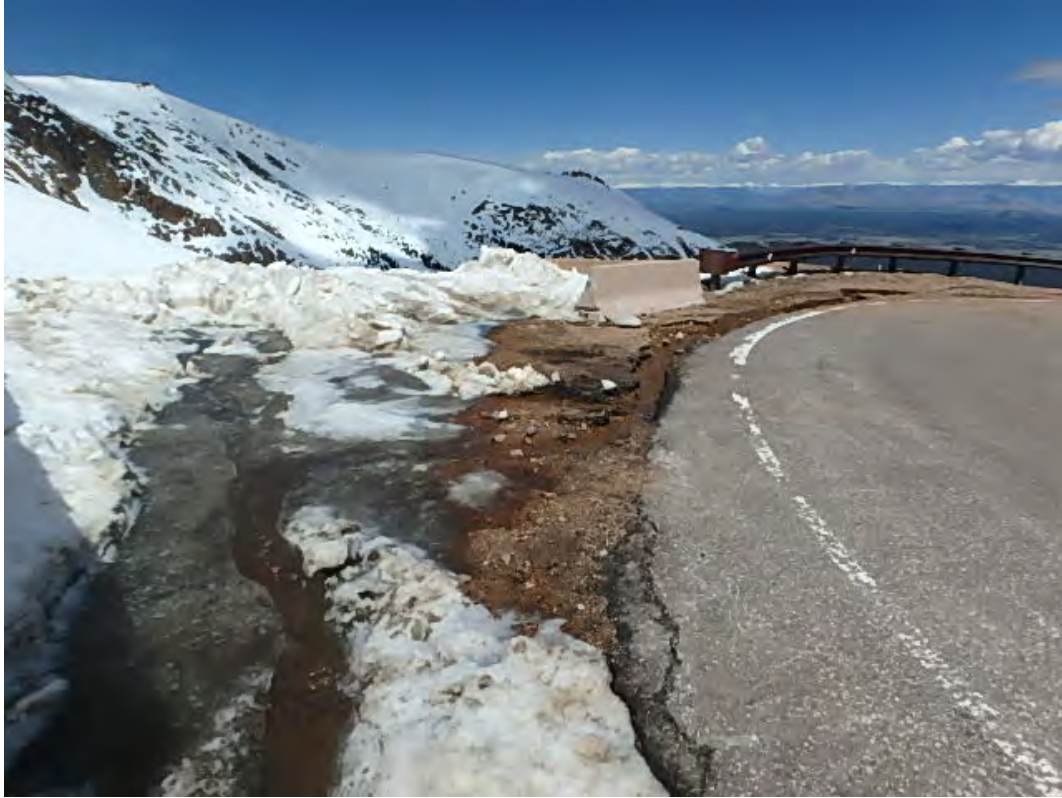
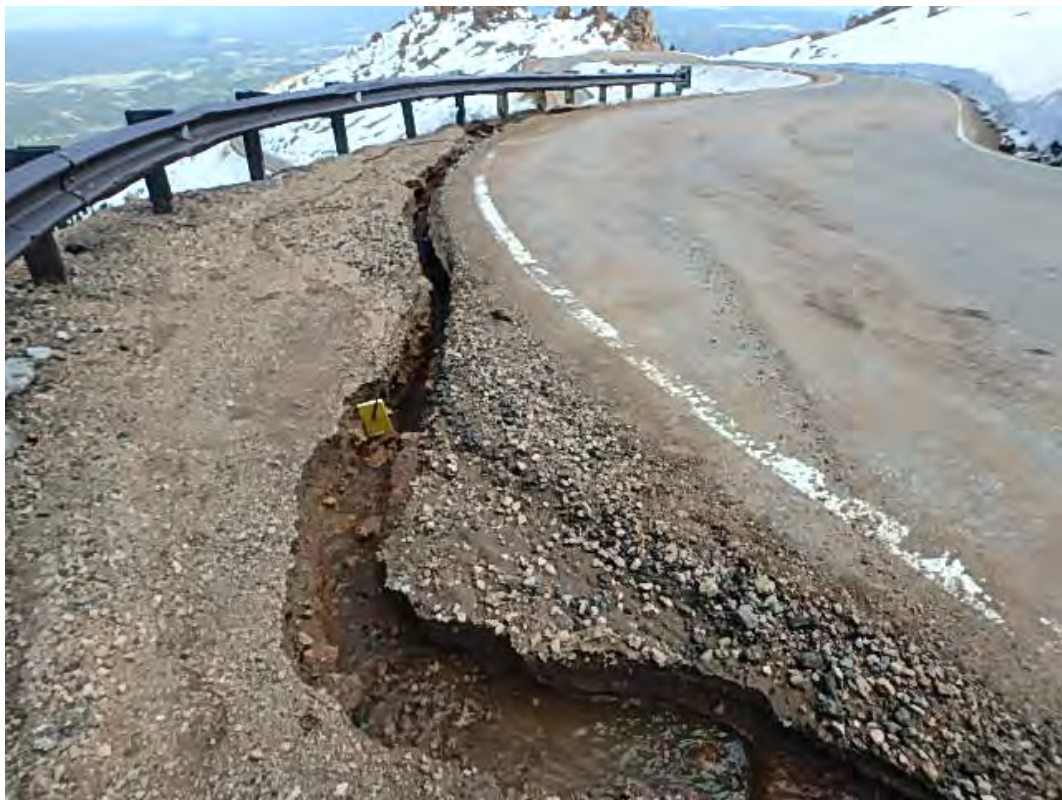
Figure 9. Ice block above 238RW (top) diverted water away from the rock weir and down the side of the highway (bottom), Pikes Peak June 1, 2015.

Heavy snowfall in the spring of 2015 above timberline affected sediment traps 236RW, 237RW, 239RW, and 241RW. Snow and ice blocks formed in the contributing drainage ditches causing rills and head cuts to form around these sites. An ice block above sediment trap 238RW diverted water and sediment away from the cut-off wall and down the side of the highway (Figure 9) to the fill slope below (Figure 10).

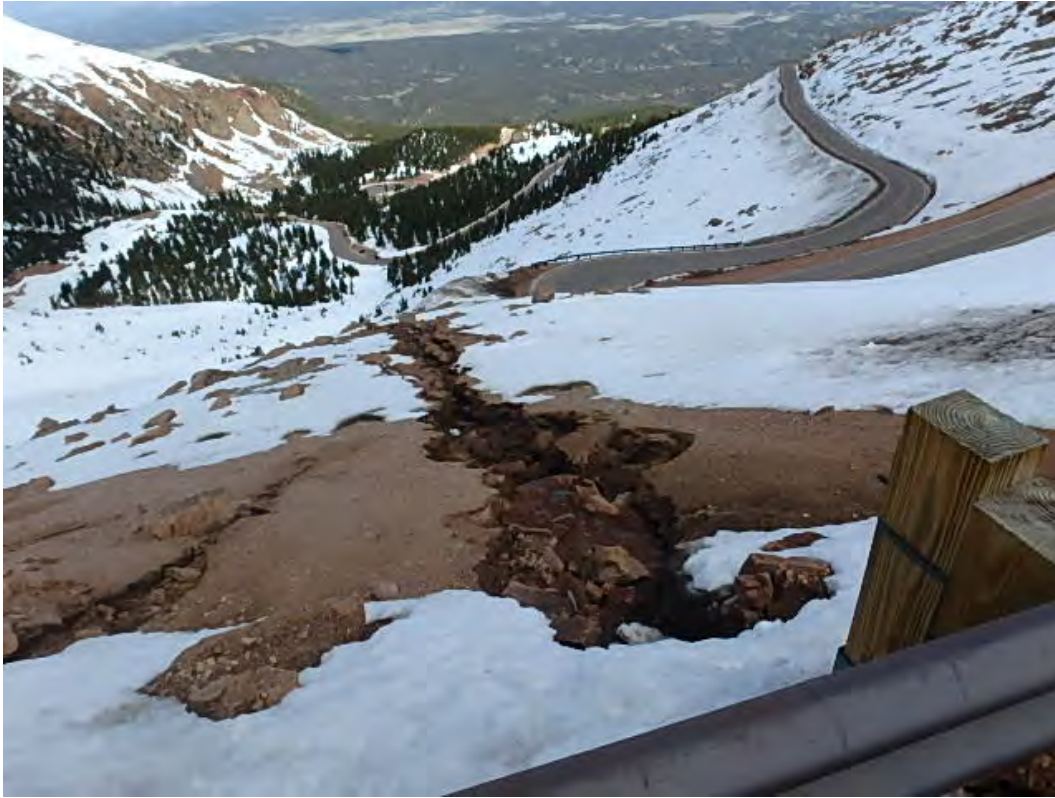
Figure 10. Water and sediment diverted away from 238RW to the fill slope below, Pikes Peak June 1, 2015.
