Assessing Restoration Outcomes in Light of Succession: Management Implications for Tropical Riparian Forest Restoration [©]

Harold Manrique-Hernández, Tamara Heartsill-Scalley, Maritza Barreto-Orta, Clarisse M. Betancourt-Román and Jorge R. Ortiz-Zayas

Ecological Restoration Vol. 34, No. 2, 2016
ISSN 1522-4740 E-ISSN 1543-4079
©2016 by the Board of Regents of the University of Wisconsin System.

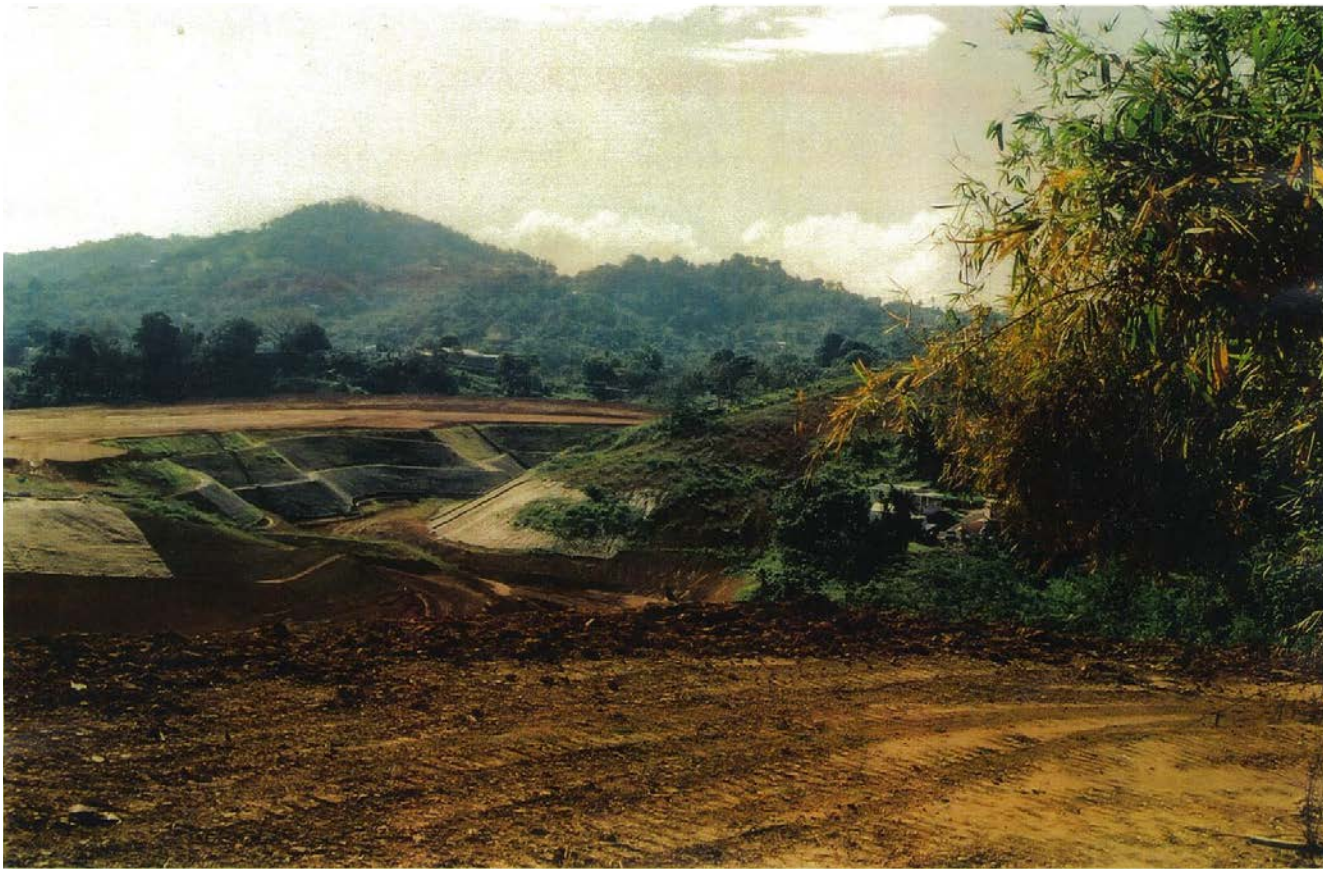
Figure 1. Southern view upstream of Quebrada Chiclana (a headwater stream of the Rio Piedras Watershed, San Juan, Puerto Rico) during the restoration project, circa 2003. *Photo Credit: J. Cruz.*

2003 order by the government of Puerto Rico to the land developer (Figure 1). The river restoration order had three main components: (1) returning the stream channel to its original morphology, (2) the removal of the filling material, and (3) reforestation of riparian areas. The re-forestation plan for Quebrada Chiclana stated two goals: “Increase the ecological value of the area to be restored when compared with the conditions before the construction and conversion of the riparian vegetation to a flat fill” and “Achieve a native tree corridor of multiple habitats and give an advantage to native species over the exotics” (Ecosystems and Associates 2003). These goals were used as the basis to determine the success of the re-forestation component of the stream restoration.

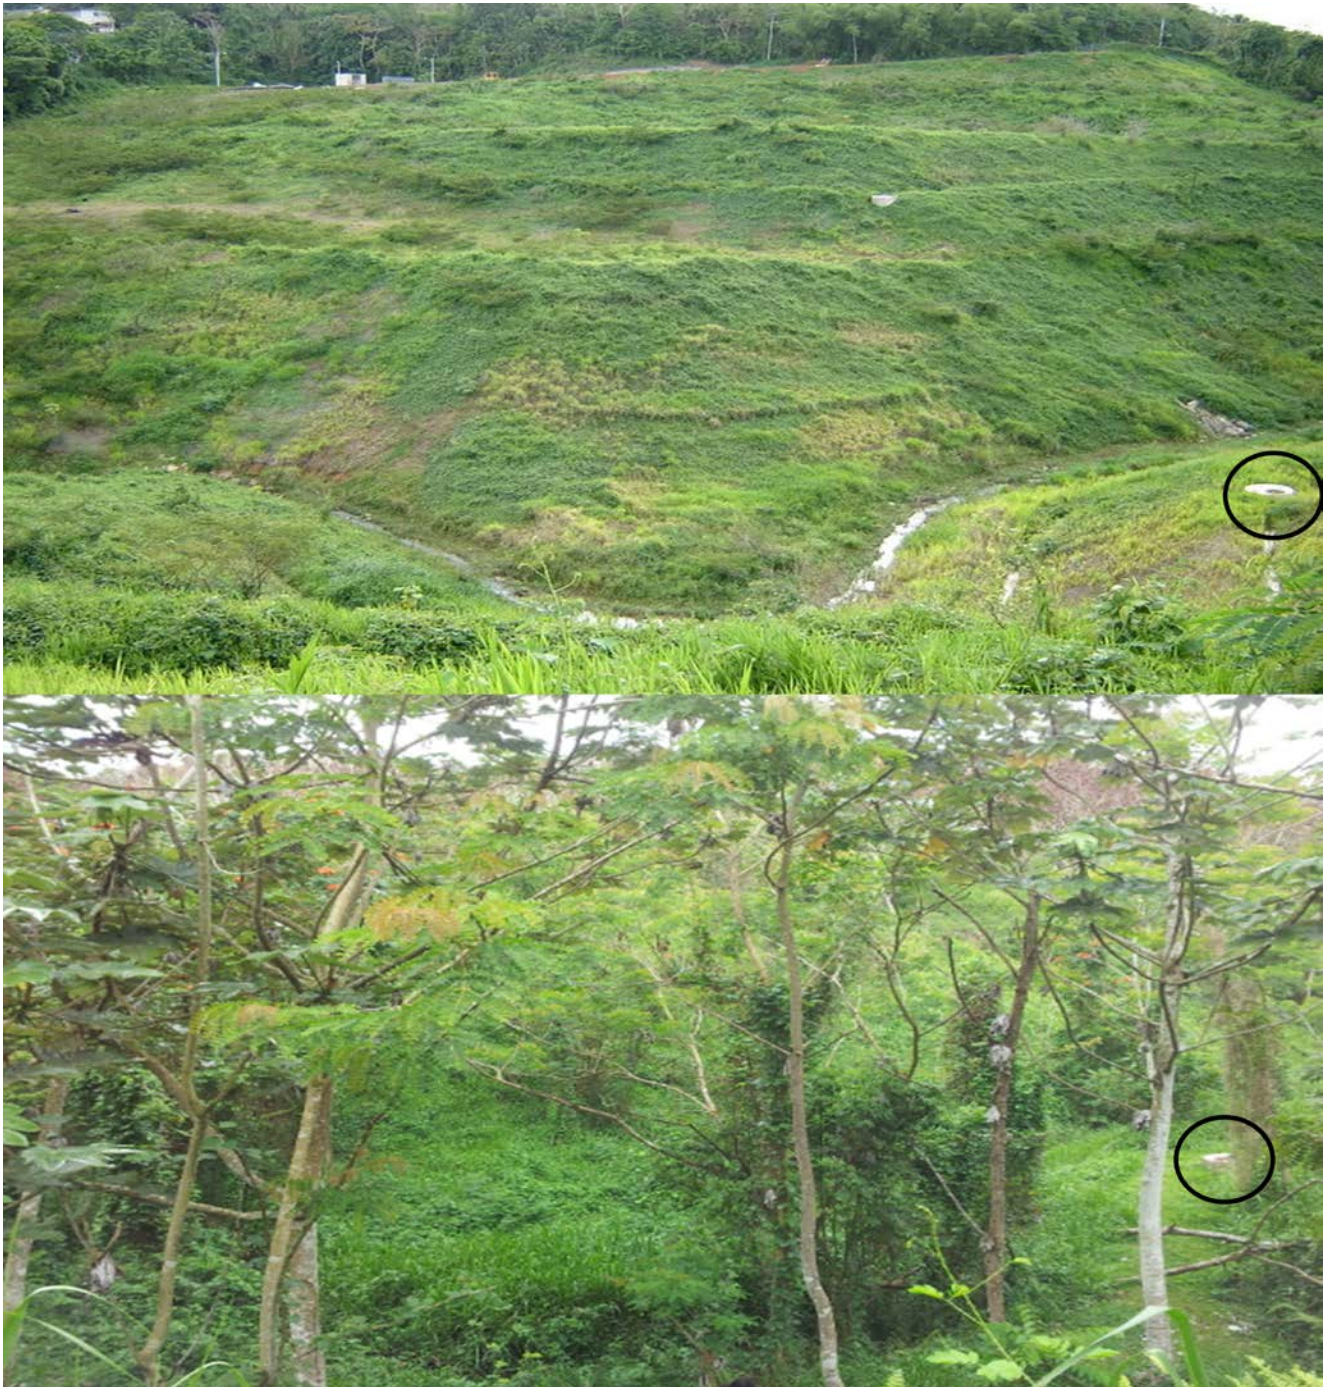
Figure 5. Forest succession in plot 3L, view from plot 3R. Top photo 2006, below 2010. A pluvial structure is marked at the right of each photo for reference.

The concept presented by Hughes et al. (2012) of natural regeneration can be observed in the Quebrada Chiclana

restored area (Figure 5). Our results present favorable natural succession after the restoration project ended. For example, the vegetation community in our study area is not as species-poor as expected, even after determining that the reforestation plan was not fully successful. Furthermore, we found no significant difference in tree species composition when comparing the restored area with reference areas. This implies that the riparian community growing in the restored area is recovering at a rate that is already showing similar structural characteristics present in the vegetation
